S-107 MEETING STREET

Bicycle and Pedestrian Road Safety Audit

Charleston, SC

MAY 2020

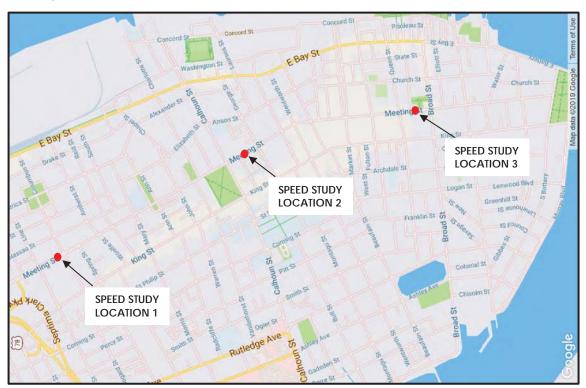
Figure 2.4.1- S-107 Speed Study Locations

A speed study at 3 different locations along the corridor was conducted to gauge normal speed variations during non-rush hours. As seen from Figure 2.4.1 and Table 2.1, average and 85th percentile speeds are slightly higher at the north end of the study area. The posted speed limit is 30 mph from the beginning of the study area and decreases to 25 mph beyond the Calhoun Street intersection at the southern end, where bicycle and pedestrian volumes increase.

Results of the speed study show mid-day 85th percentile speeds below the posted speed limits. This aligns with Figures 2.3.5 to 2.3.7, which shows only 4% of vehicular crashes and none of the bicycle or pedestrian crashes were caused by "driving too fast for conditions".

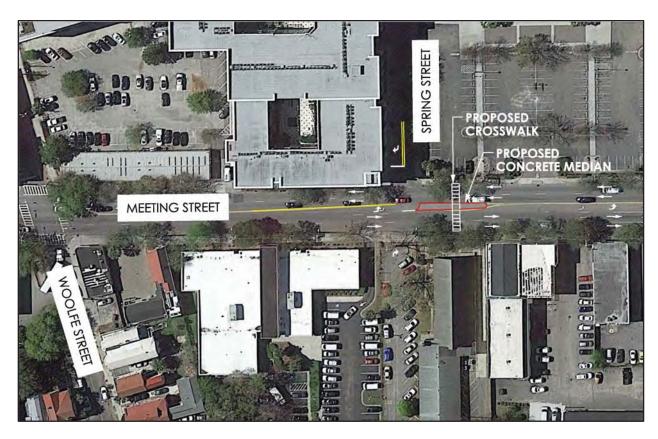
Proposed Raised Median Concept Sketch

Several rear-end, sideswipe and angle crashes were observed between Line and Columbus Street (96) and Columbus-Spring St. (22), likely due to illegal turns and movements by drivers, pedestrians and bicyclists. The northbound left-turn storage onto Columbus St. is reported to be fully adequate.

Consider constructing a raised median between Columbus and Spring Street, as shown in the following exhibit. Extend the median southward and channelize it to accommodate northbound left turns onto Spring Street but enforce left-turn restrictions from Spring St. This can help enforce Right-in/Right-out access for the western driveway as intended. It will also convert the two eastern driveways, where left turns involve crossing the left turn lane. The concrete median can be used to provide a pedestrian refuge. It appears this median would not conflict with the LCRT project alternate, but it should be verified before implementation. The northbound left-turn storage onto Columbus Street is reported to have adequate storage capacity without queueing into the striped median.

Typical driveway related crash reduction of 40% for access management improvements.

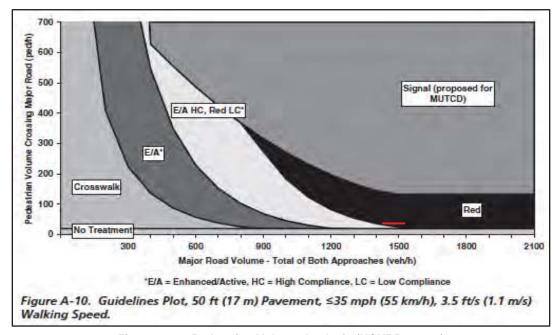
Figure 3.2.1- Pedestrian Volume Analysis (NCHRP report)

The uncontrolled crosswalk near the Charlotte St intersection has alternating signals that flash constantly, which appears to cause drivers to not notice when a pedestrian is actually present. Additionally, parking spots adjacent to the uncontrolled crosswalk at the Charlotte St intersection confuse drivers and hinder visibility.

- Noted conflicts at crossing locations
- Inadequate conspicuity/visibility of the crosswalk and pedestrian
- Insufficient pedestrian separation from traffic

- An RRFB appears warranted and is recommended. Also, Yield bars with R1-5 Yield Here to Pedestrian signs are recommended on Meeting St. approaching the crosswalk at this location.
 Typical pedestrian crash reduction of 50% for installation of RRFB.
- Also, consider removing parking space adjacent to the uncontrolled crosswalk to improve visibility.
