# S-104 KING STREET

## Road Safety Audit Charleston, SC

**Bicycle and Pedestrian Road Safety Audit**

Downtown Charleston, South Carolina

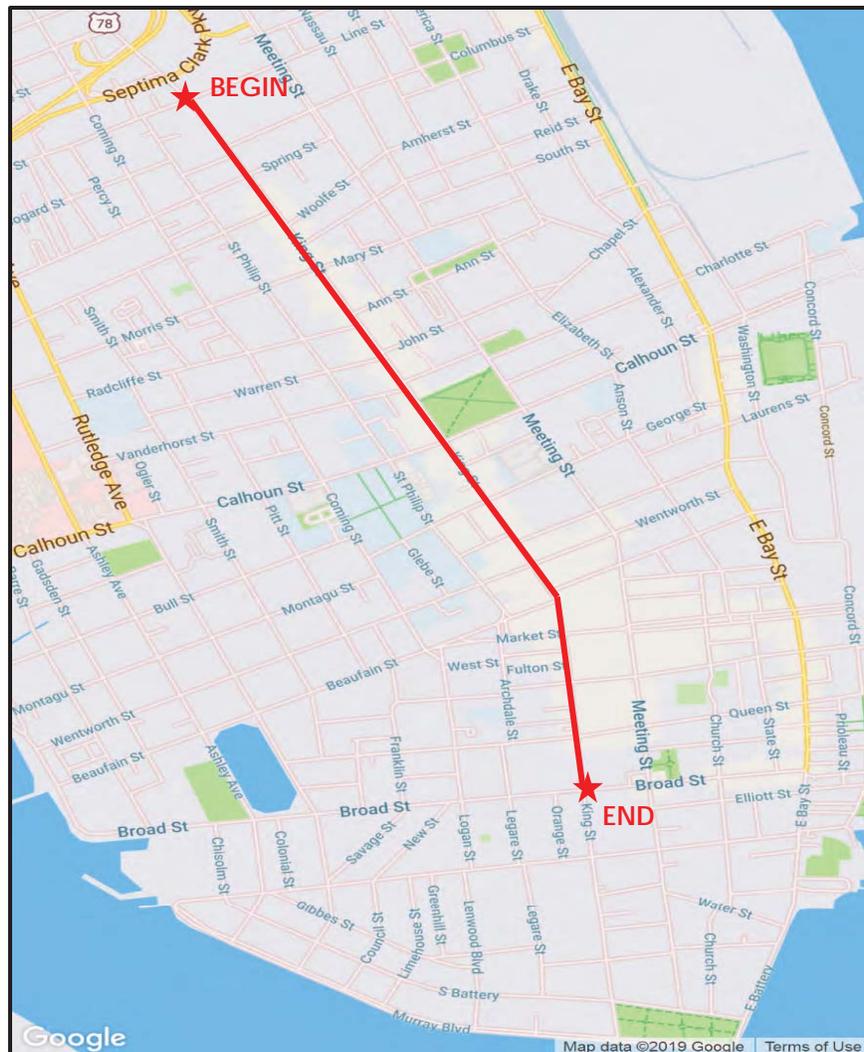
Figure 2.1- Project Study Area

The project study area begins at the intersection of Line Street in the northern end and extends southward to Broad Street. These limits are shown below in Figure 2.1. S-104 has active bicycle, pedestrian, vehicular, and transit traffic. It serves residential, office and retail properties, with several attractions for both tourists and local residents. In addition to numerous shops and restaurants, some popular destinations along this corridor include Marion Square, Visitors Center, Gibbes Museum of Art and White Point Garden. The College of Charleston is also nearby, adding to nonvehicular and vehicular traffic when school is in session.

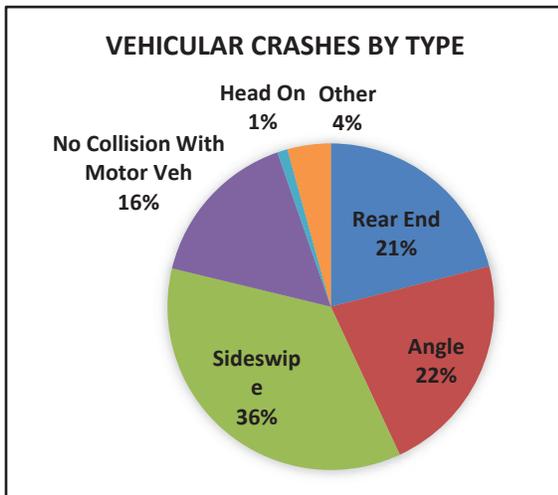
Figure 2.3.1- S-104 Crashes by Type

As seen in Figure 2.3.1, sideswipe crashes are the most common type, at 36% of vehicular crashes. There were no fatal crashes reported over the entire period. Crashes designated as no collision with motor vehicle are typically collisions with a fixed object. Figure 2.3.2 depicts crashes by severity, which shows 17% of vehicular crashes resulted in injuries. Around 83% of the crashes were reported to be property damage only (PDO). Figure 2.3.5 shows various cause of vehicular crashes along the study area.

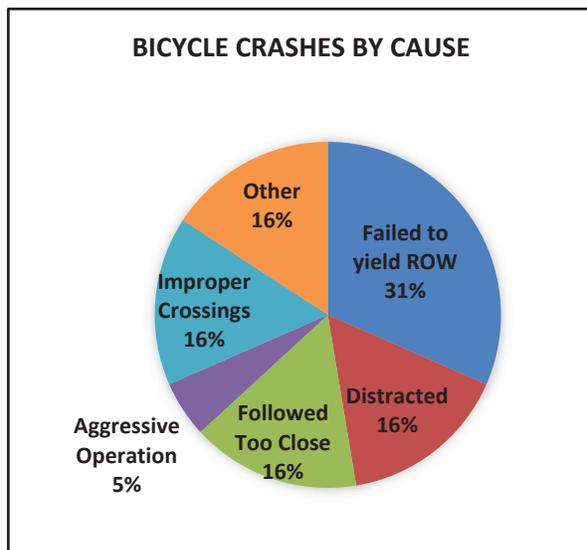
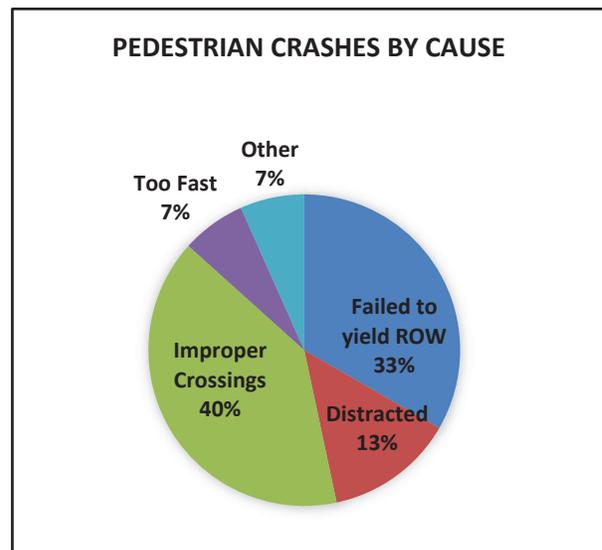
Figure 2.3.6 - S-104 Bicycle Crashes by Cause

Figure 2.3.7 - S-104 Pedestrian Crashes by Cause

Figures 2.3.6 and 2.3.7 depict bicycle and pedestrian crashes by probable cause, respectively along the study area. Most of the crashes are caused by some form of improper maneuver (Failed to Yield Right of Way and Improper Crossings). Bicycle and pedestrian crashes occurring due to failure to yield right of way account for 31% and 33% respectively.

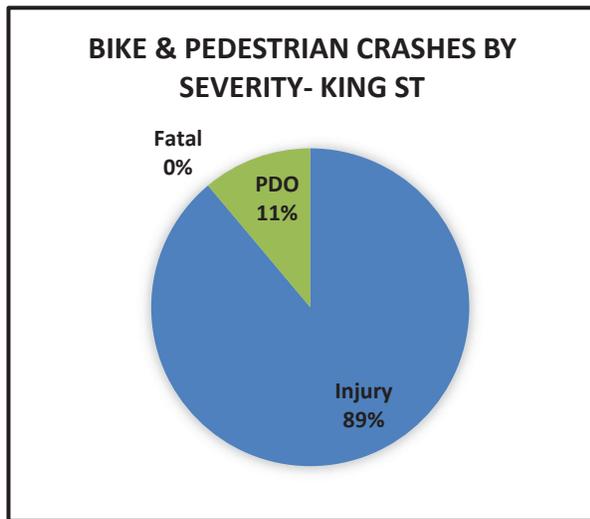
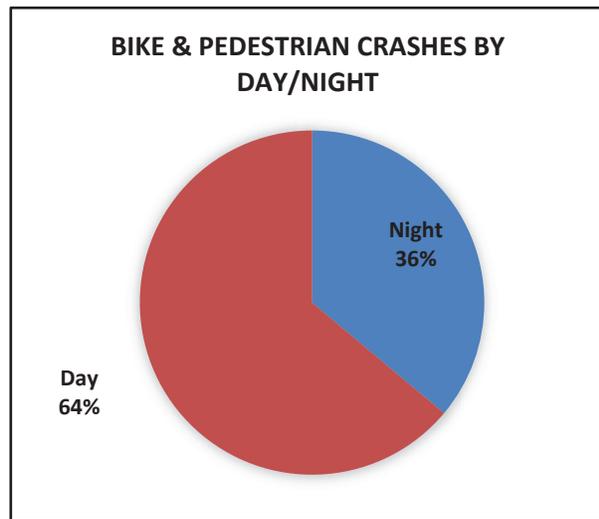
Figure 2.3.8 - S-104 Bicycle and Pedestrian Crashes by Severity

Figure 2.3.9 - S-104 Bicycle and Pedestrian Crashes by Day/Night

Figures 2.3.8 and 2.3.9 depict bicycle and pedestrian crashes by severity and day/night, respectively along the study area. 32 of the 36 crashes resulted in injuries. 36% of the bicycle and pedestrian crashes occurred at night.

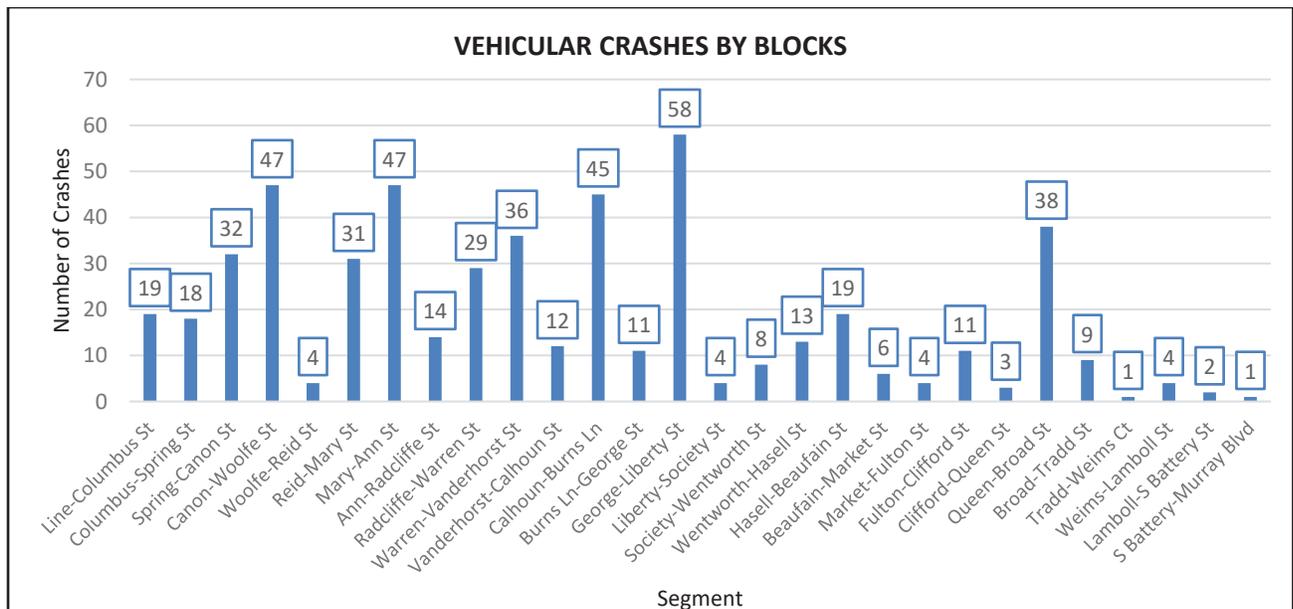
Figure 2.3.10 - S-104 Vehicular Crashes by Block

From Figure 2.3.10, it is observed that George-Liberty St. had the highest number of crashes overall.

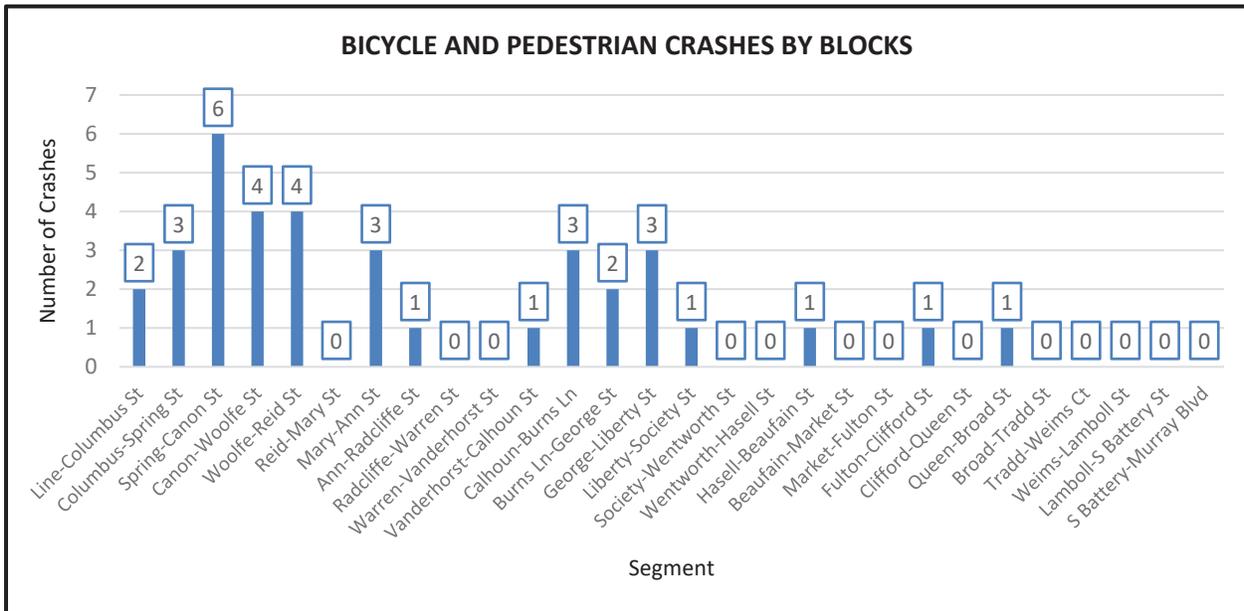
Figure 2.3.11- S-104 Bicycle and Pedestrian Crashes by Block

As seen from Figure 2.3.11, bicycle and pedestrian crashes were concentrated in the northern half of the project, from Line St. to Liberty St.

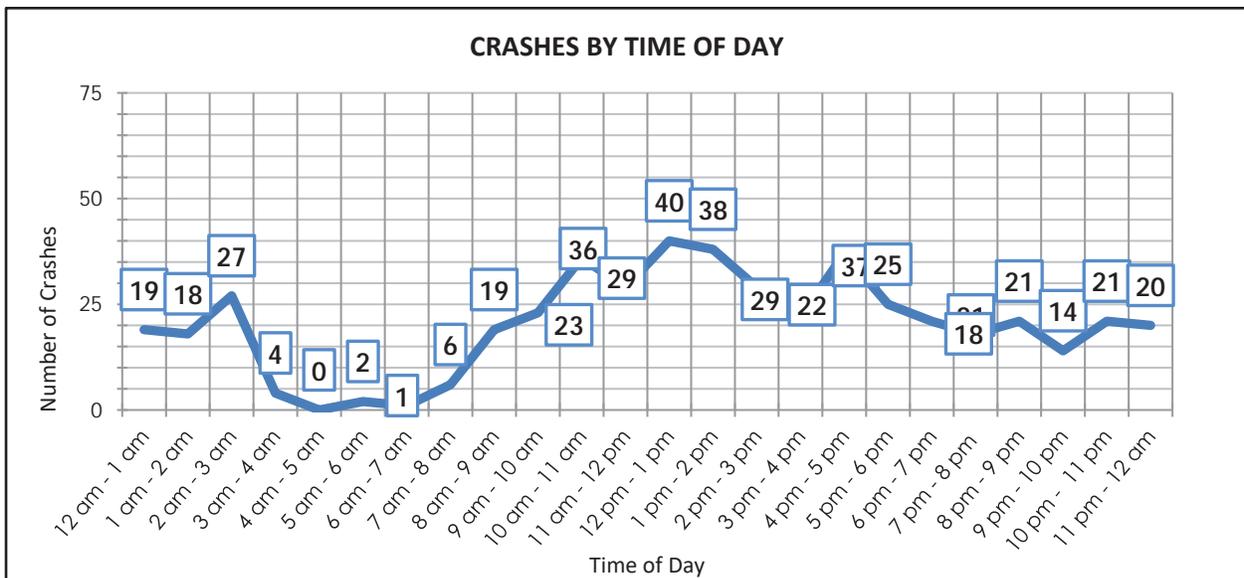
Figure 2.3.12 – S-104 Crashes by Time of Day

As seen in Figure 2.3.12, the majority of the crashes occur between 8:00 AM and 7:00 PM, but night-time crashes continue until 3:00 AM. This is likely due to higher overall traffic and pedestrian volumes, with a lot of movements around popular restaurants and bars at night. From Figure 2.3.13 below, it is observed that bicycle and pedestrian crashes occur from 7:00 AM to 3:00 AM.

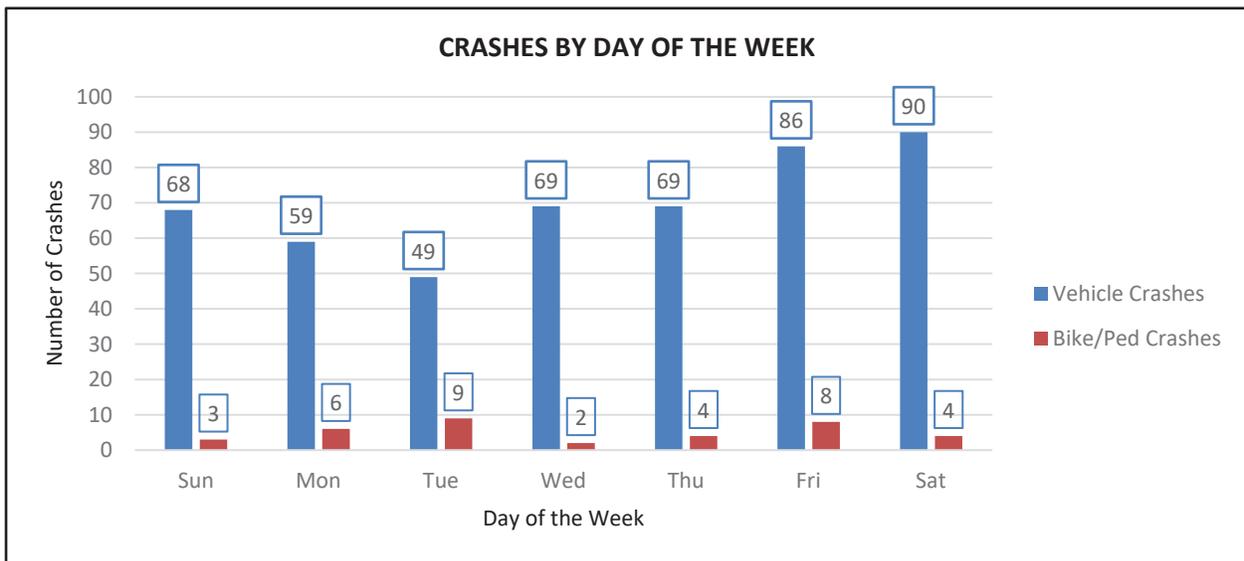
Figure 2.3.14 – S-104 Crashes by Day of the Week

As seen in Figure 2.3.14, most crashes are spread throughout the week, with vehicular crashes being the highest on Fridays and Saturdays.

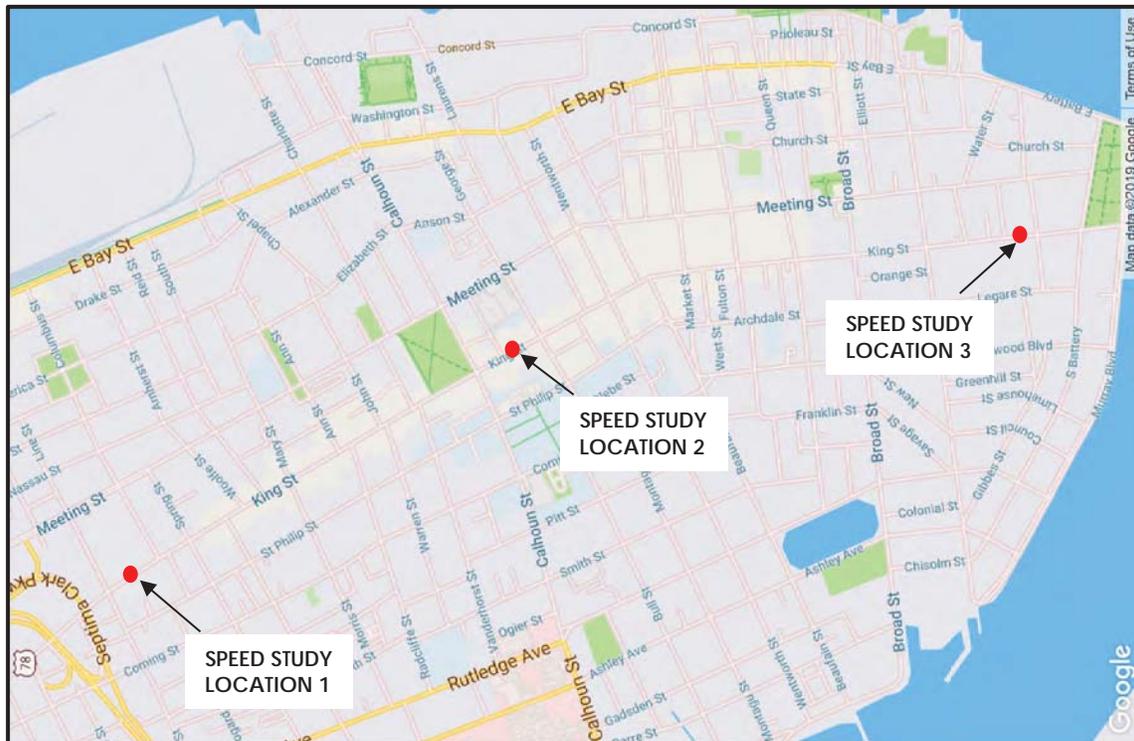
Figure 2.4.1 – S-104 Speed Study Locations

A speed study at 3 different locations along the corridor was conducted to gauge normal speed variations during non-rush hours. As seen from Figure 2.4.1 and Table 2.1, average and 85<sup>th</sup> percentile speeds are higher at the north end of the study area. The posted speed limit is 30 mph from the beginning of the study area and decreases to 25 mph beyond the Calhoun St intersection at the southern end.

Location	1	2	3
Time	10:45am to 11:00am	11:00am to 11:30am	11:30am to 11:45am
Limit (mph)	30	25	25
Average (mph)	22	20	14
85th percentile (mph)	25	22	15

Results of the speed study show mid-day 85<sup>th</sup> percentile speeds below the posted speed limits. This aligns with Figures 2.3.5 to 2.3.7, which shows only 3% of vehicular crashes and none of the bicycle or pedestrian crashes were caused by “driving too fast for conditions”.

The speed data suggests the 30mph speed limit posting might be reduced to 25mph. Also, the City of Charleston has noted citizens asking what the posted speed limits are.

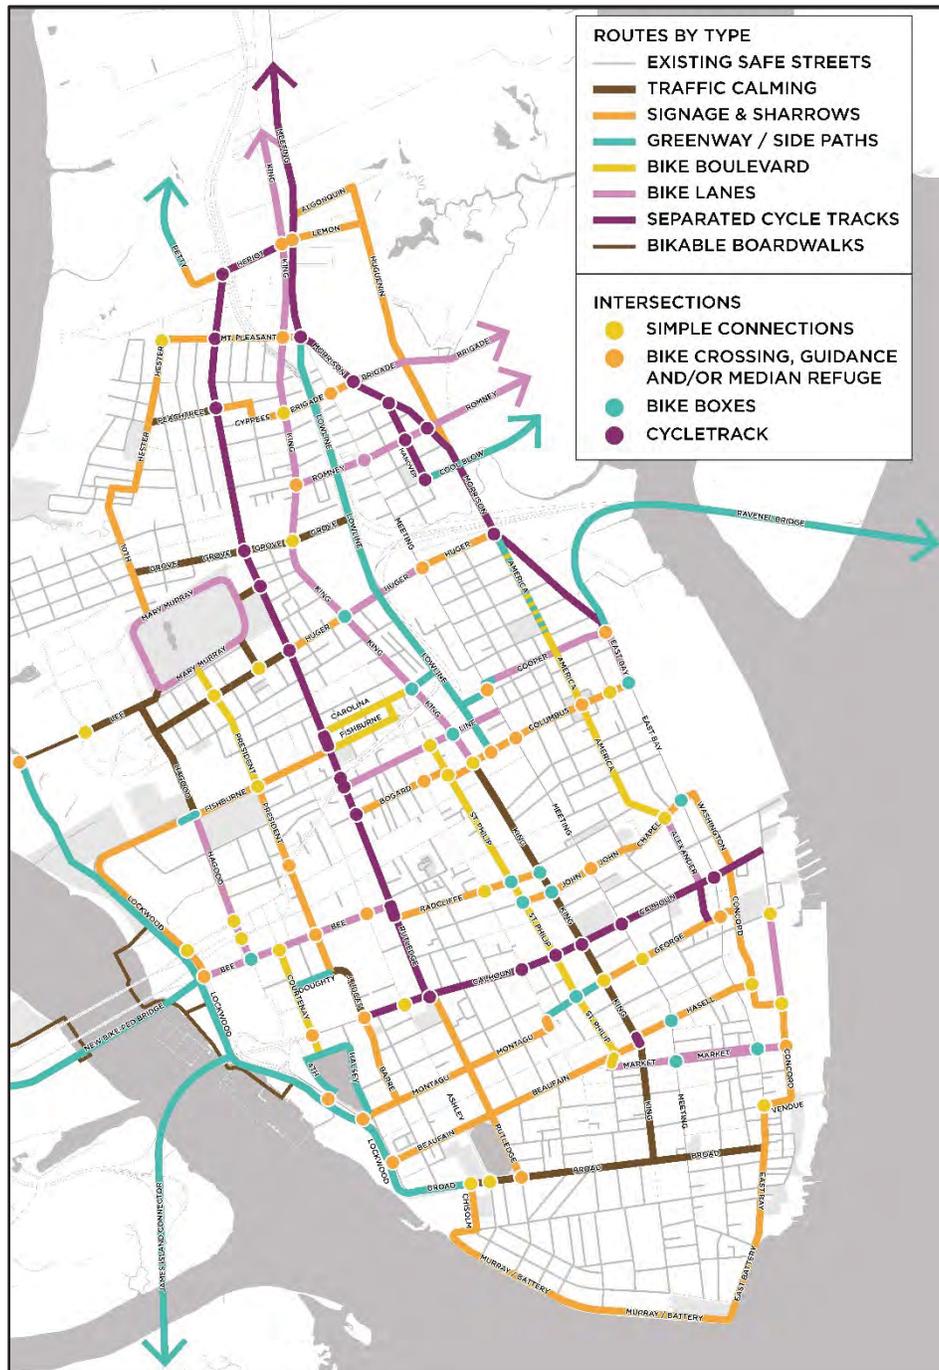
Figure 2.5.1- People Pedal Plan

The City's People Pedal Plan provides recommendations for bicycle and pedestrian improvements throughout the peninsula (Figure 2.5.1). For King Street, the plan recommends bicycle lanes southward to its intersection with Columbus Street. From Columbus Street to Broad Street, it recommends traffic calming. The plan also calls for several intersection improvements along King Street that will need to occur as separate projects, with the S-104 recommendations in the study intended to not conflict with those improvements. The plan shows 85<sup>th</sup> percentile speeds that are close to those listed in this study. In both cases, the speed data collected only represents short periods of time for a given day. The plan is shown in Appendix G.

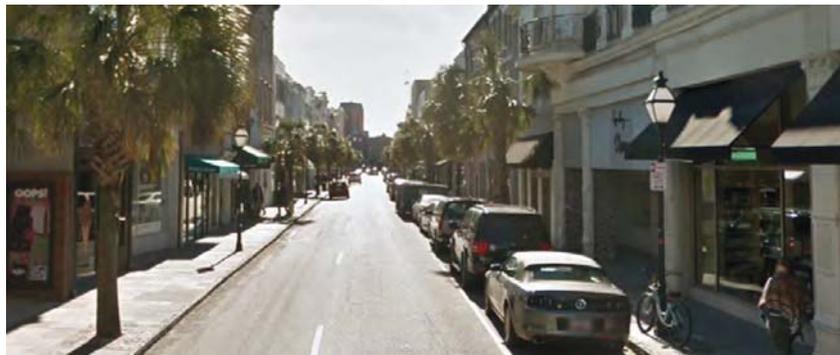
*S-104 Midblock Typical Section*

This study recognizes the need to provide safe pedestrian crossings that reflect pedestrian routing demand. Efforts are made to provide direct crossing routes as feasible. The exhibits on the following page show existing and proposed pedestrian crossings for the S-104 corridor using signalized crosswalks, stop controlled crosswalks, pedestrian refuge islands, curb extensions, and Rectangular Rapid Flashing Beacons (RRFBs). These safety countermeasures address both side street approach crossings and mainline S-104 crossings. Each countermeasure is recommended where found to be applicable per FHWA, MUTCD, and NACTO guidelines.

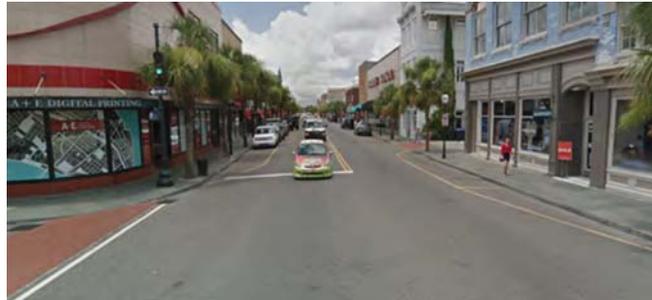
Crosswalks are missing across some uncontrolled approaches and at several signalized intersection approaches.

*Missing crosswalk at the Mary St. intersection (southbound approach)*

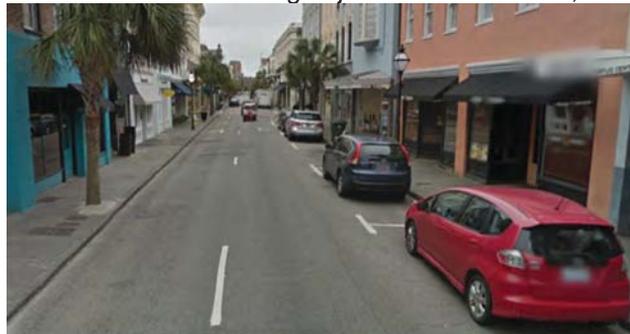
King St. has two 9-foot southbound lanes from Calhoun St. to Wentworth St., with on-street parking on the west side. There are frequent truck loading/unloading activities in this area and this section has experienced 63 sideswipe crashes. Drivers tend to avoid driving adjacent to each other, so capacity is not fully utilized.

*Tight spacing and narrow lanes between Calhoun St and Wentworth St.*

Consider a road diet to reduce S-104 to one through lane and a southbound bicycle lane. A representative typical section is shown below:

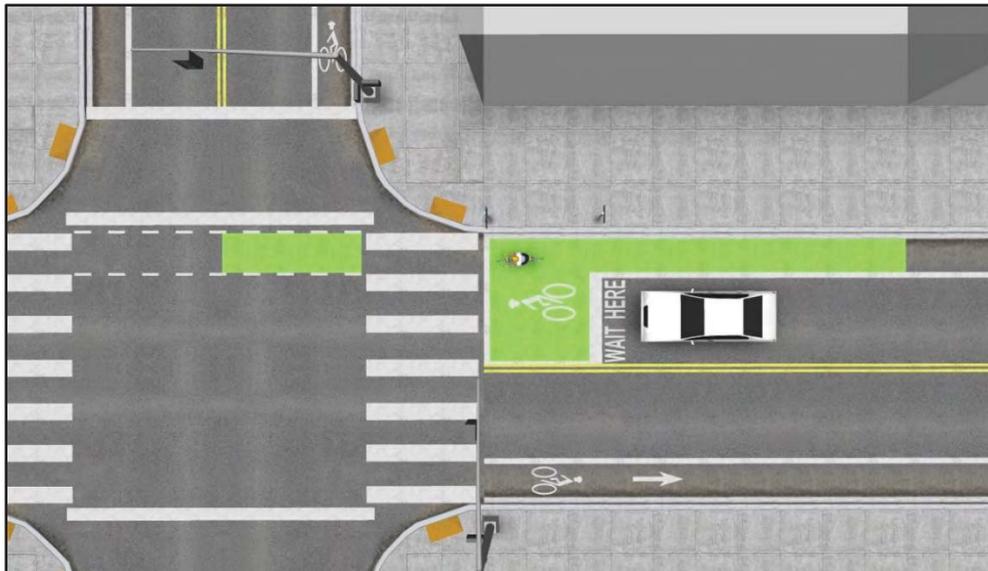
#### Colored Pavement at Intersection

Consider adding colored pavement at conflict points such as driveways and intersections. The example below illustrates colored pavement, with a bicycle box application for signalized intersections.

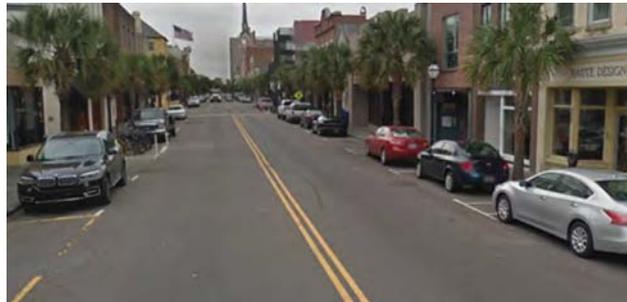
The previous improvement covers S-104 from Calhoun Street southward. The remaining section from Line Street to Calhoun Street typically has 12 to 13 feet travel lanes with narrow on-street parking as shown below:

For this section, consider marking the through lanes, with shared lane markings (sharrows) to alert road users of the bicycles and assist bicyclists with lateral positioning. The shared lane markings are to be applied in conjunction with the bike lane.

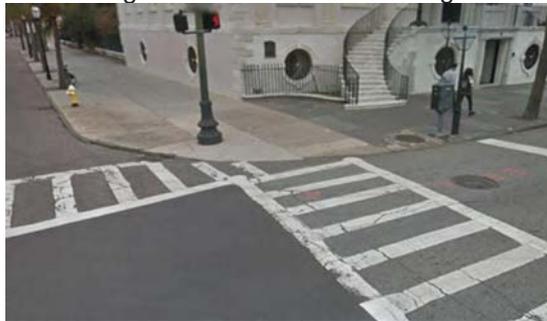
Detectable warning surfaces are missing at several locations throughout the corridor.

*Sidewalk without detectable warning surface at Broad St.*

Consider adding detectable warning surfaces on ADA ramps where missing. (Approximately 6 ramps)

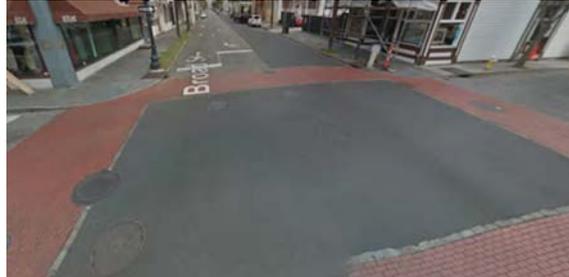
The following stamped asphalt crosswalks are missing white lines along their edges in these intersections: Hutson St., Calhoun St., Burns Ln., Wentworth St. and Broad St.

*Existing brick crosswalk at Broad St. without white edge lines*

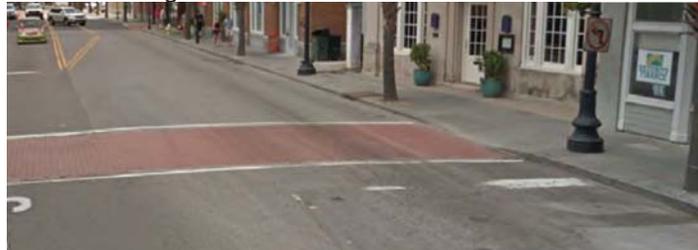
Pavement marking and RPM markings in several sections are worn out.

*Existing pavement markings worn out*

Consider upgrading pavement markings and RPM throughout the corridor. King St. is scheduled for resurfacing from Hasell St. to South Battery, which should cover that section. Coordination with recommendations from this study may be needed.

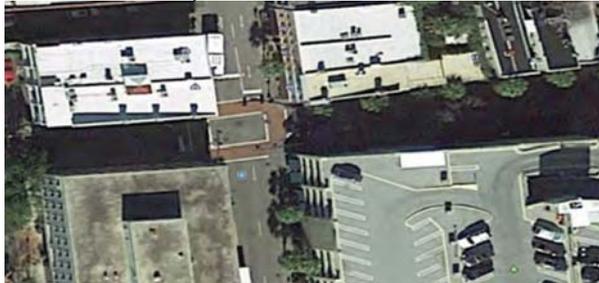
Some stop bars appear too far from their respective crosswalks.

*Stop bar placed too far from the crosswalk at the Queen St intersection (SB)*

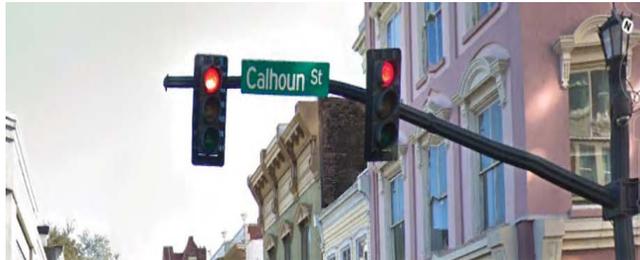
The following signalized intersections lack retroreflective backplates: Line St., Columbus St., Spring St., Calhoun St. and Wentworth St.

*Existing Calhoun St. signal heads without retroreflective backplates.*

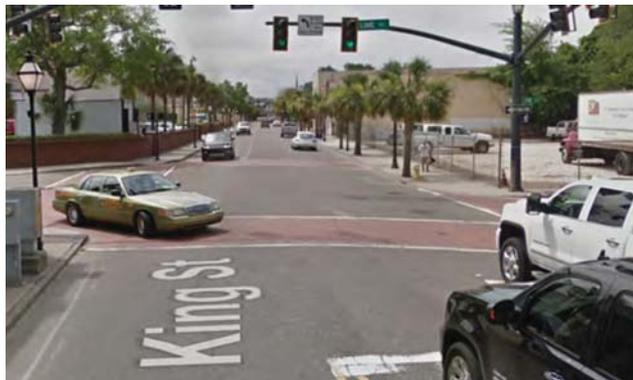
- The southbound inside lane is currently signed as “Left Turn Only”, except 4-6 PM and 7-9 AM. This coincides with the southbound outside lane parking restrictions immediately south of Line St. When parking is allowed, southbound through lane traffic has to shift immediately after crossing the intersection and then shift back over again prior to Columbus Street to access the through lane. This routing is confusing for drivers.

*S-104 Southbound at Line St.*

- Pedestrian crossing for the eastern Line Street approach is long.
- There are no detectable warning surfaces on sidewalk ramps.

- Perform a traffic study to see if the southbound Left Only designation could remain during AM and PM peak hours. This would simplify the intersection and maintain consistency throughout the day. King St. southbound could be restriped from Line St. to Columbus St. to maintain a consistent southbound through lane. The parking spaces (approximately 4) would be removed. A concept sketch is provided on the following page.
- Apply updated and additional left turn arrows for King St. southbound to better alert drivers.
- For the eastern Line Street approach, shift the stop bar and crosswalk back as shown in the concept sketch below to reduce pedestrian crossing distance. New ADA ramps will be needed. Prohibit right turns on red to address sight distance obstruction.

- Install detectable warning surfaces on sidewalk ramps.

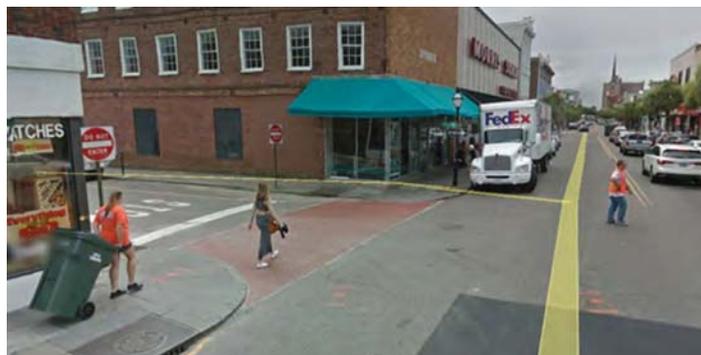
- The side street turns from Reid St onto S-104 are difficult because of limited sight distance.
- There are no detectable warning surfaces on sidewalk ramps.
- No pedestrian accommodations for crossing S-104 exist between Cannon Street and Mary Street/Morris Street which are 620 feet apart.

*Limited sight distance for Reid St.*

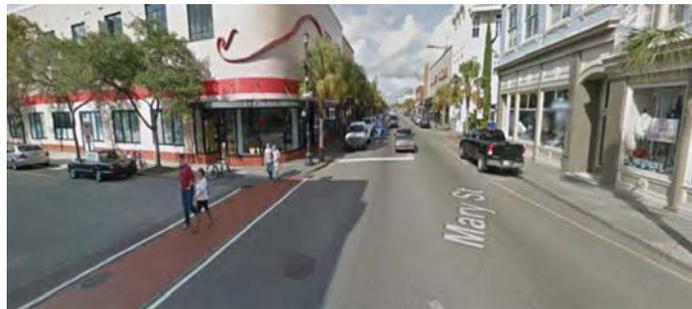
- Missing crosswalk at the northern approach of the intersection.
- There are no detectable warning surfaces on sidewalk ramps.
- Sight visibility is restricted for the Morris Street and Mary Street side street approaches.

*Morris St. crosswalk*

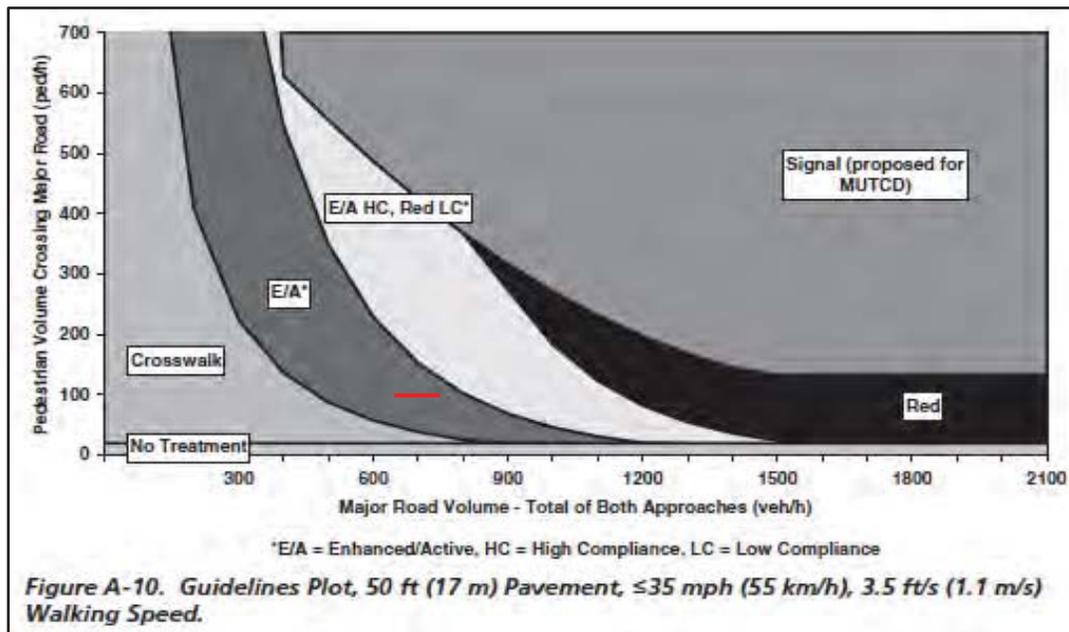
Figure 3.2.1- Pedestrian Volume Analysis (NCHRP report)

15-min Intervals	Pedestrian Counts
6:00 to 6:15 pm	42
6:15 to 6:30 pm	38
6:30 to 6:45 pm	40
6:45 to 7:00 pm	23
7:00 to 7:15 pm	16
7:15 to 7:30 pm	13
7:30 to 7:45 pm	15
7:45 to 8:00 pm	10

**Peak Hour Count: 143 pedestrians (6:00pm to 7:00pm)**

— Count Period: 6:00 PM to 7:00 PM, with estimated volume

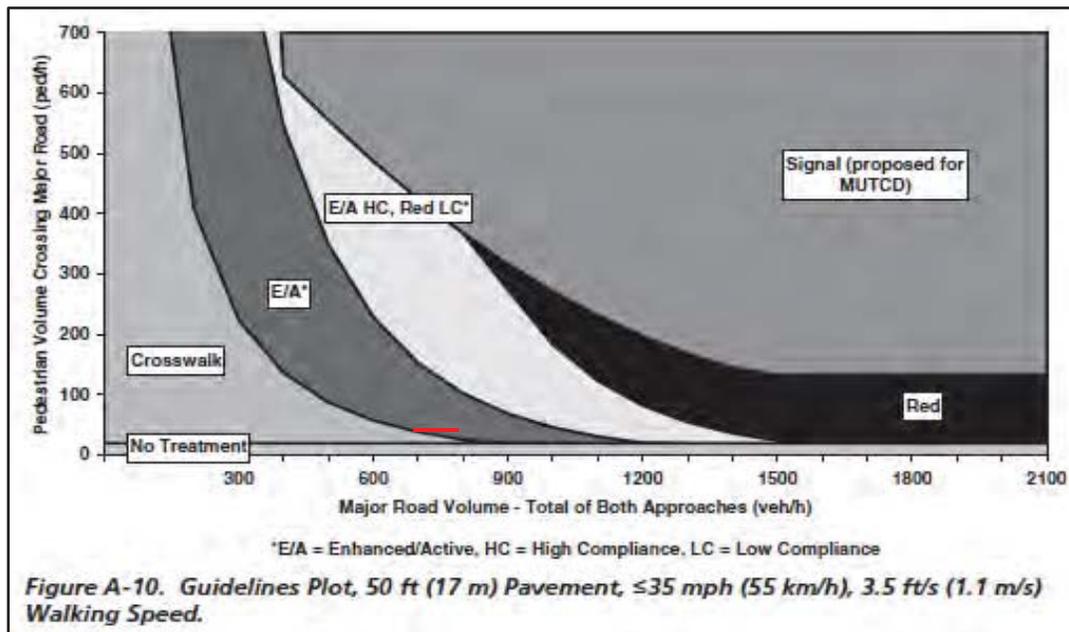
Figure 3.2.2- Pedestrian Volume Analysis (NCHRP report)

15-min Intervals	Pedestrian Counts
3:30 to 3:45 pm	8
3:45 to 4:00 pm	5
4:00 to 4:15 pm	4
4:15 to 4:30 pm	3
4:30 to 4:45 pm	4
4:45 to 5:00 pm	2
5:00 to 5:15 pm	5
5:15 to 5:30 pm	6

**Peak Hour Count: 20 pedestrians (3:30pm to 4:30pm)**

— Count Period: 3:30pm to 4:30pm, with estimated volume

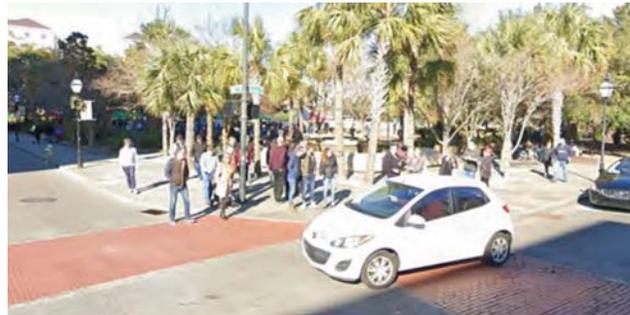
- Pedestrian activity is high at this intersection, at times conflicting with vehicular demand.

*Pedestrian wait to cross intersection*

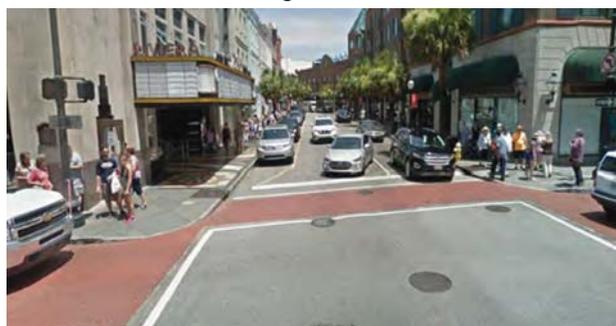
- Pedestrian activity is high at this intersection, at times conflicting with vehicular demand.
- Sidewalk at the southwest corner is damaged.

*Pedestrian wait to cross intersection*

- Perform a traffic analysis to evaluate converting this intersection to include a pedestrian scramble phase that accommodates diagonal crossings.
- Add a “No Right Turns on Red” sign.
- Repair sidewalk at the southwest corner of the intersection.
