SAINT PHILIP STREET

Bicycle and Pedestrian Road Safety Audit Charleston, SC

S-106 Saint Philip Street

Bicycle and Pedestrian Road Safety Audit

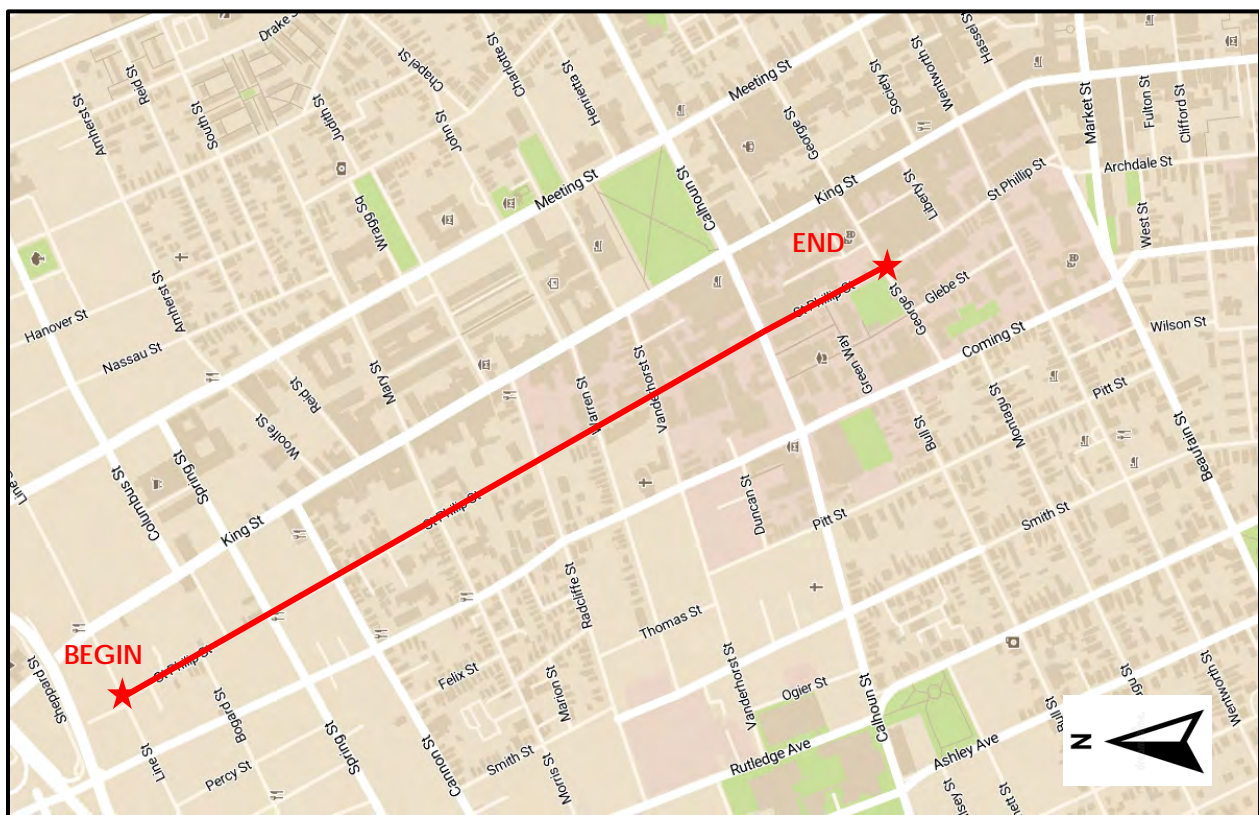
Figure 2.1- Project Study Area

The project study area begins at the intersection of Line Street in the northern end and extends southward to George Street. These limits are shown below in Figure 2.1. S-106 has active bicycle, pedestrian, vehicular, and transit traffic. It serves residential, office and retail properties, with several attractions for both tourists and local residents. The College of Charleston is also nearby, adding to nonvehicular and vehicular traffic when school is in session.

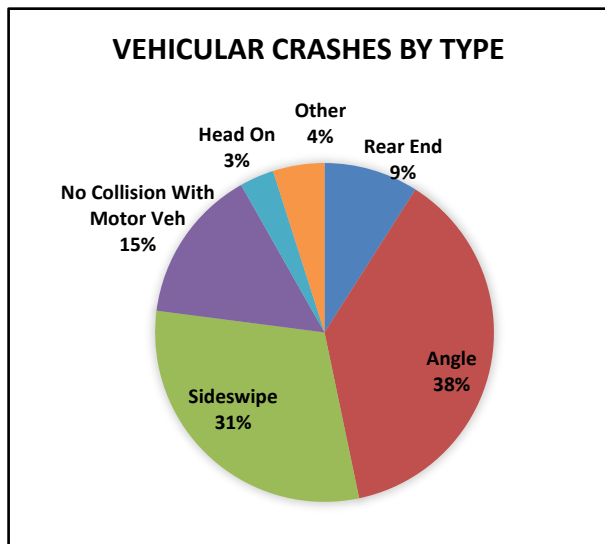
Figure 2.3.1- S-106 Crashes by Type

As seen in Figure 2.3.1, angle crashes are the most common type, at 38% of all vehicular crashes. Crashes designated as no collision with motor vehicle are typically collisions with a fixed object. Figure 2.3.2 depicts vehicular crashes by severity along the study area, which shows 18% of all crashes resulted in injuries. 82% of the crashes were reported to be property damage only (PDO). No fatal crashes were reported over the entire period. From Figure 2.3.3, 39% of all vehicular crashes occurred at night time.

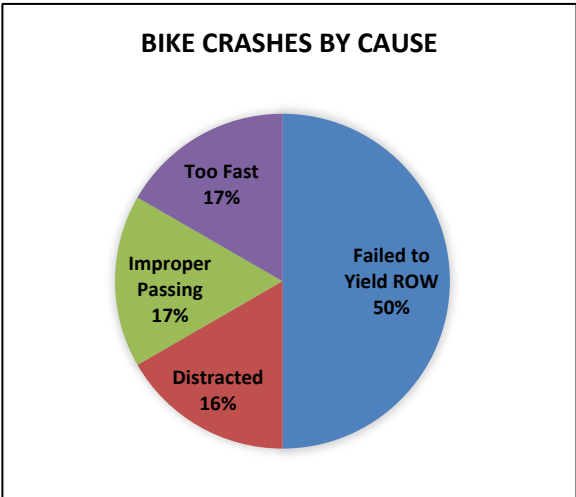
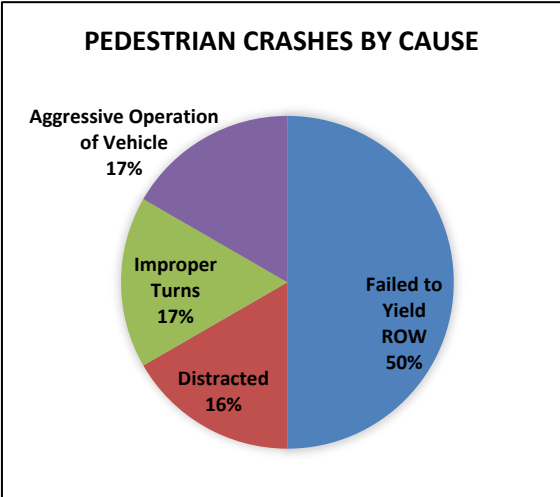
Figures 2.3.6 and 2.3.7 depict bicycle and pedestrian crashes by probable cause, respectively along the study area.

Results of the speed study show mid-day 85th percentile speeds are close to the posted speed limits. This aligns with Figures 2.3.5 to 2.3.7, which shows only 6% of vehicular crashes, 14% of bicycle crashes and 0% of pedestrian crashes were caused by “driving too fast for conditions”.

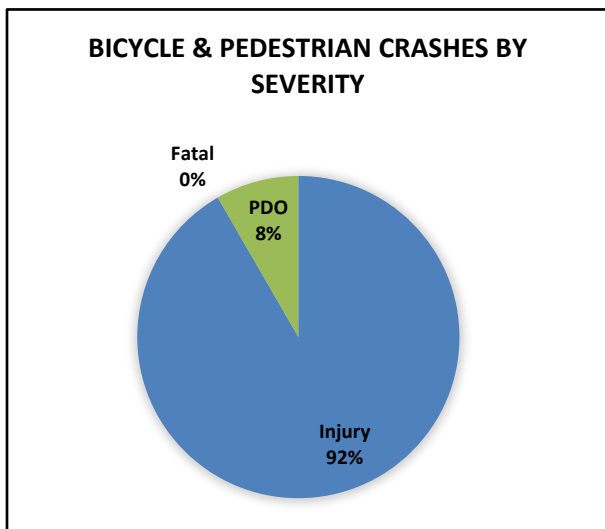
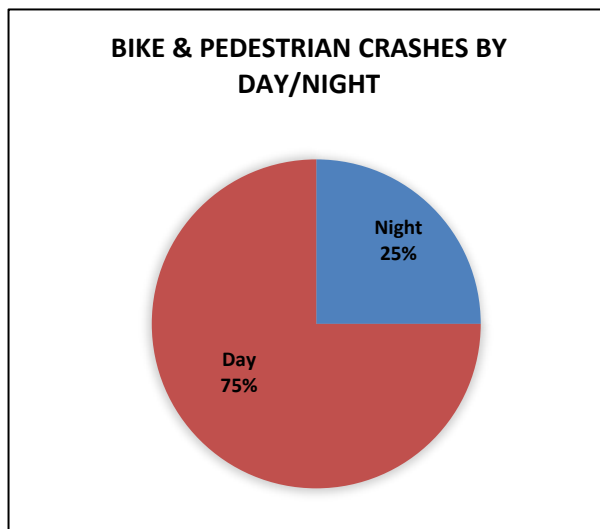
Figures 2.3.8 and 2.3.9 depict bicycle and pedestrian crashes by severity and day/night, respectively along the study area. 11 of the 12 crashes resulted in injuries. 25% of the bicycle and pedestrian crashes occurred at night.

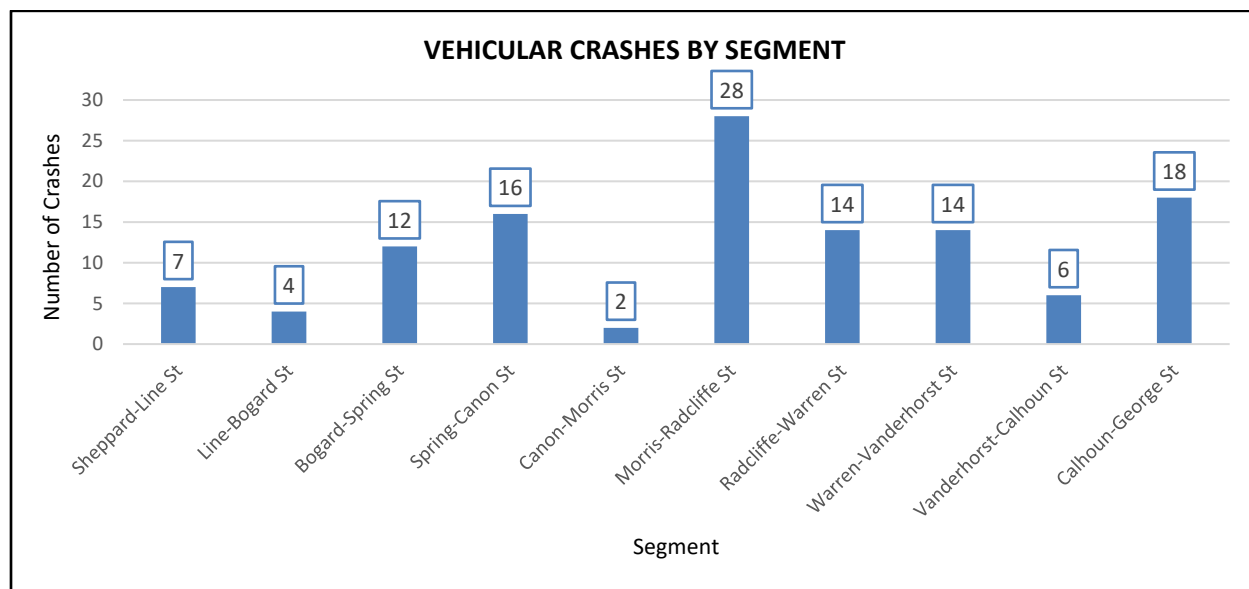
Figure 2.3.10- S-106 Vehicular Crashes by Segment

Figure 2.3.10 shows that the segment from Morris Street to Radcliffe Street had the highest number of crashes overall, followed by the segment from Calhoun Street to George Street.

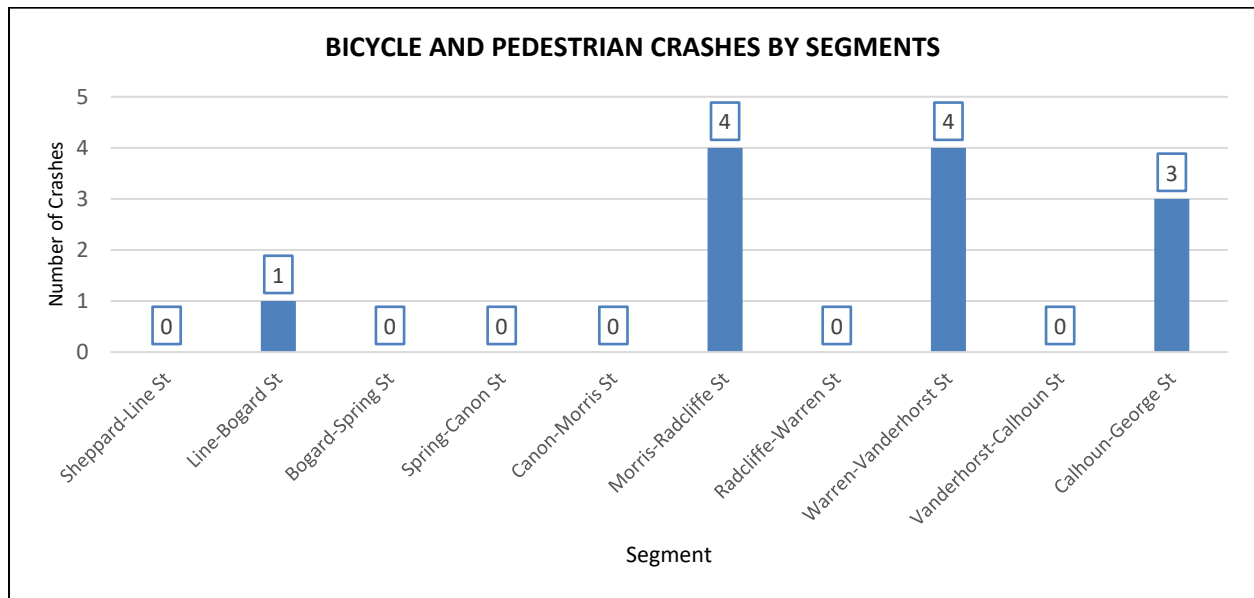
Figure 2.3.11- S-106 Bicycle and Pedestrians Crashes by Segment

As seen from Figure 2.3.11, the bicycle and pedestrian crashes are largely concentrated in three segments.

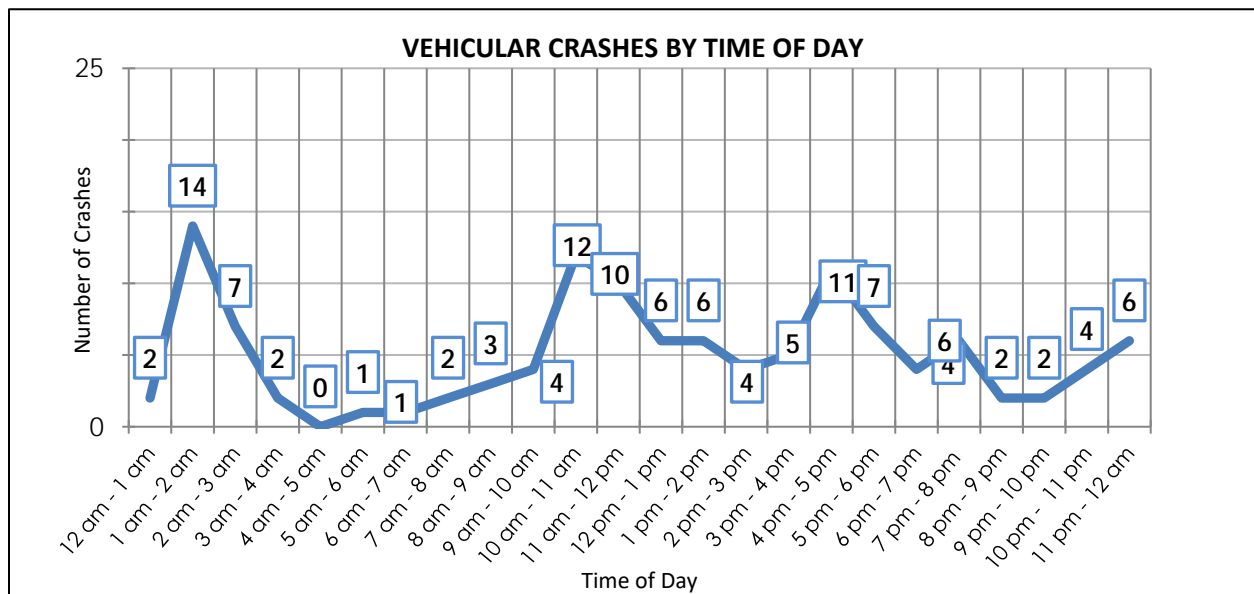
Figure 2.3.12 - S-106 Vehicular Crashes by Time of Day

As seen in Figure 2.3.12, majority of the crashes occur between 9:00 AM and 8:00 PM, but night-time crashes continue until 4:00 AM. Vehicular crashes spiked from 1:00 AM to 2:00 AM. These 14 crashes (between 1:00 AM to 2:00 AM) occurred throughout the corridor. Two of them were DUI crashes.

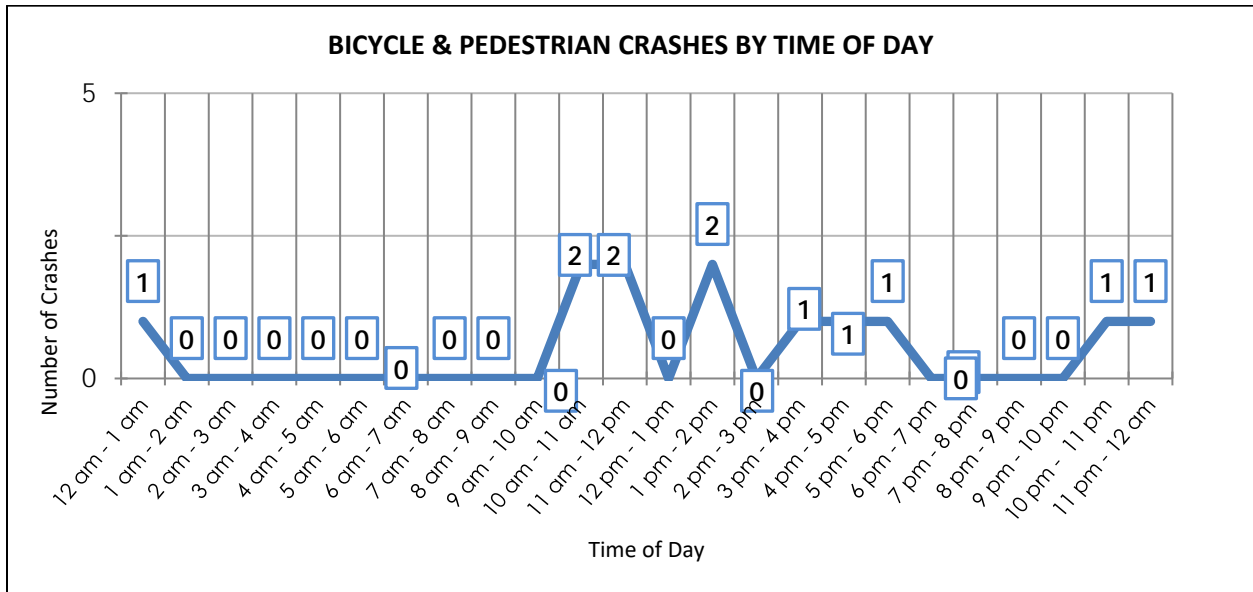
Figure 2.4.13- S-106 Bicycle & Pedestrian Crashes by Time of Day

Figure 2.3.13 shows that majority of the bicycle and pedestrian crashes occur from 10:00 AM to 1:00 AM.

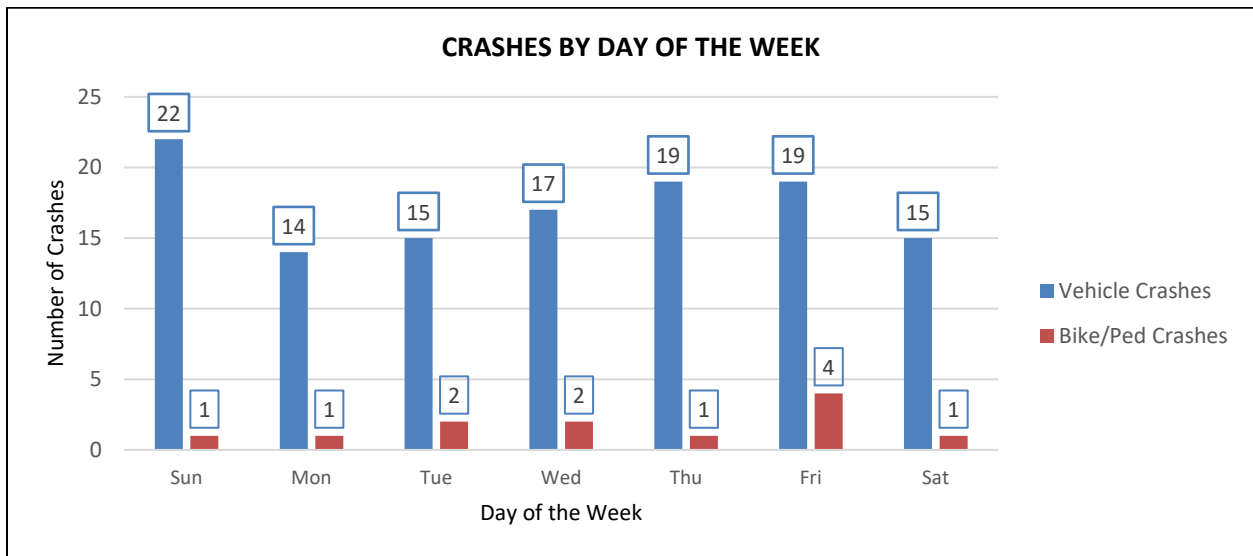
Figure 2.3.14 - S-106 Crashes by Day of the Week

As seen in Figure 2.3.14, crashes are generally spread throughout the week. Vehicular crashes are highest on Sundays.

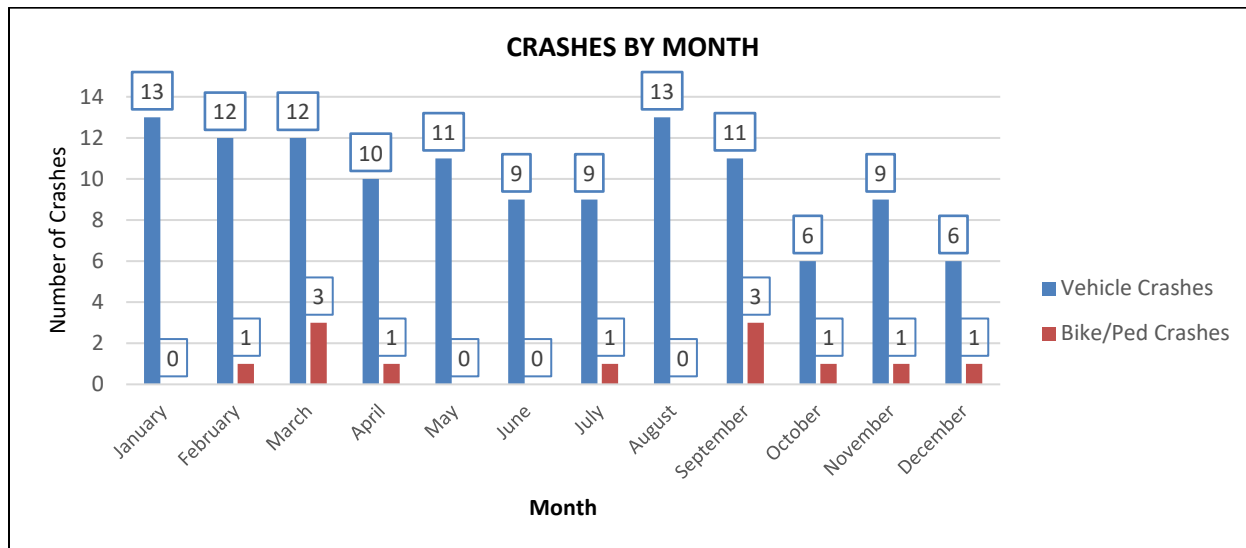
Figure 2.3.15 - S-106 Crashes by Month

Crashes by month are depicted in Figure 2.3.15. Crashes are highest from January to March.

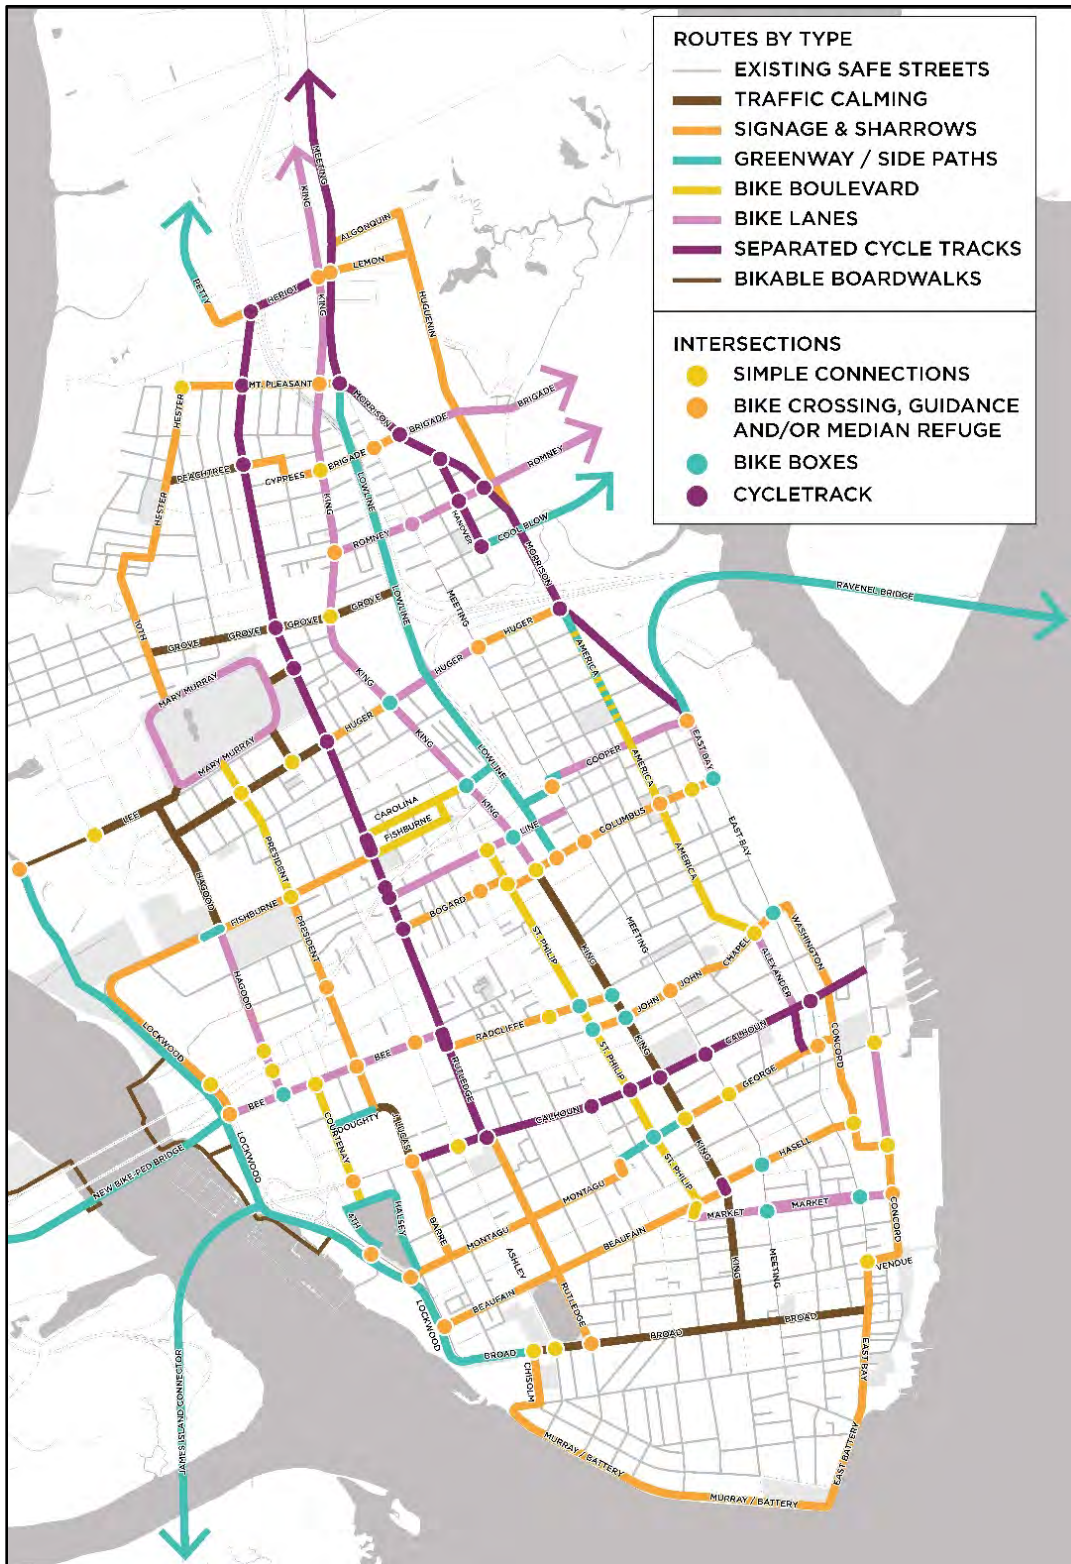
Figure 2.5.1- People Pedal Plan

The City's People Pedal Plan provides recommendations for bicycle and pedestrian improvements throughout the peninsula (Figure 2.5.1). For Saint Philip Street, it recommends adding Sharrows (Shared Lane Markings) as an interim solution between Line Street and Calhoun Street. Final recommendations call for making this street a 'bicycle boulevard' to provide cyclists a safe and direct route. This plan also calls for bike boxes at Radcliffe Street, John Street and George Street intersections, and cycle track treatment through the Calhoun Street intersection. The plan is shown in Appendix F.

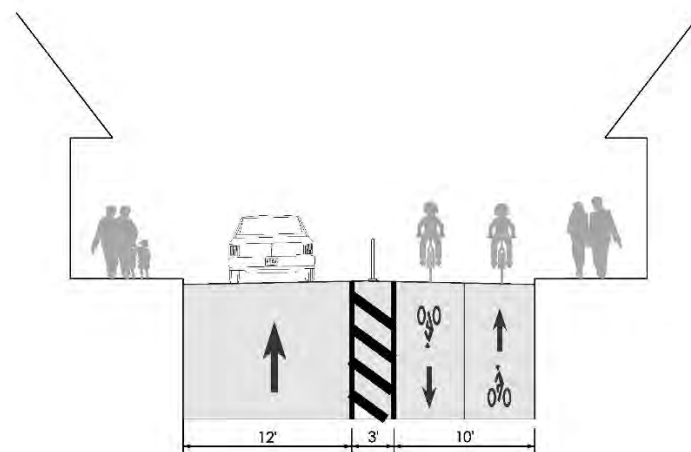
This section of S-106 is currently a one-way street with dual southbound lanes. Consider performing a traffic study to evaluate reducing S-106 to one travel lane with a dedicated two-way cycle track. A representative typical section is shown below:

These improvements could potentially be extended further south along S-106 under a separate project.

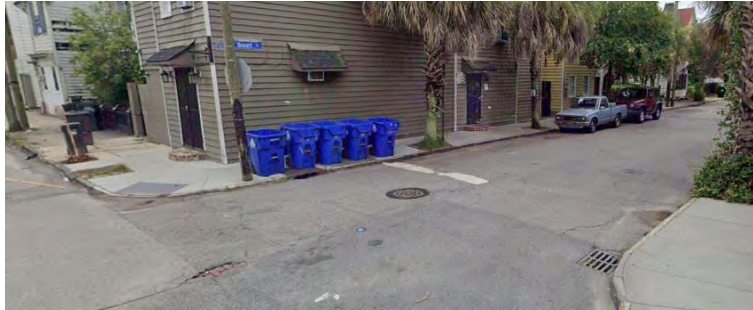
Crosswalks are missing across two of the stop-controlled side streets approaches, Bogard Street and Rodgers Alley.

Missing crosswalk at Bogard St.

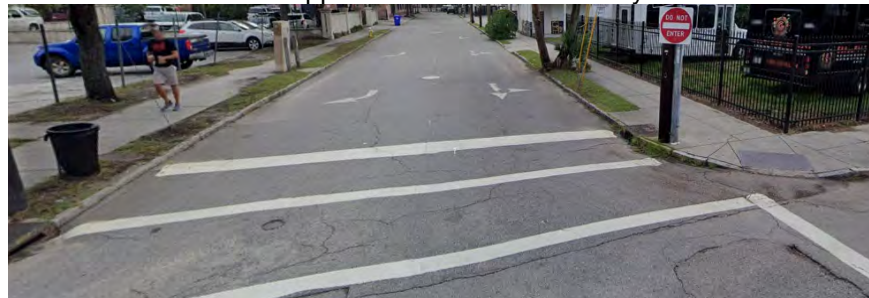
Existing crosswalks at some side street approaches are not ladder-style

Existing crosswalk at Morris St.

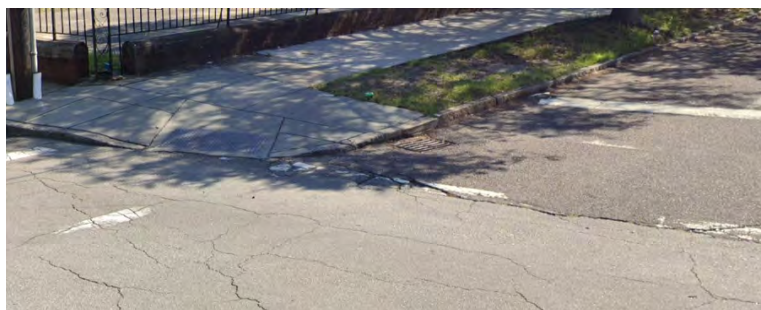
Some ADA ramps do not align with crosswalks across several approaches.

A ramp at the Radcliffe St. intersection not aligning with the crosswalk

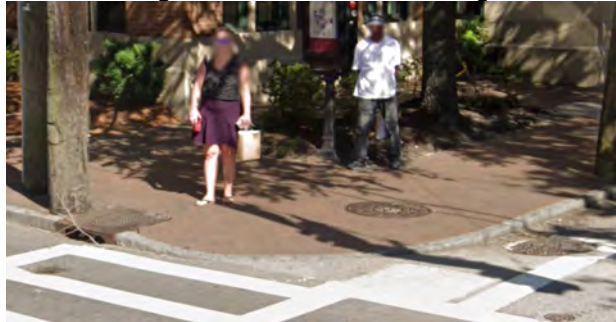
Detectable warning surfaces are missing at several locations throughout the corridor.

Sidewalk without detectable warning surface at Calhoun St.

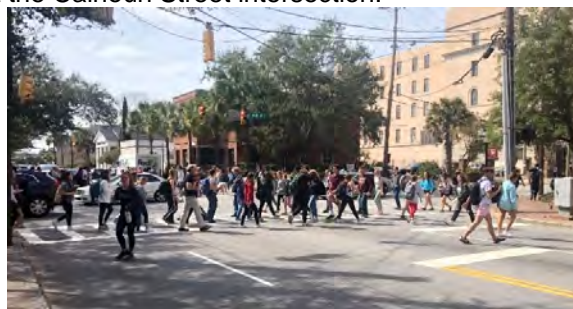
Pedestrian activity is high at the Calhoun Street intersection.

Heavy pedestrian activity at Calhoun Street intersection

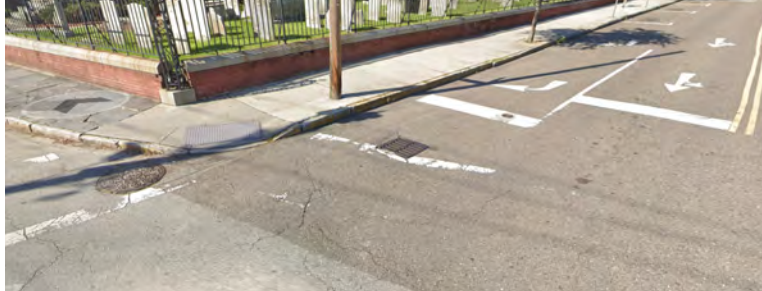
Pavement marking and RPM markings in several sections are worn out.

Existing pavement markings worn out

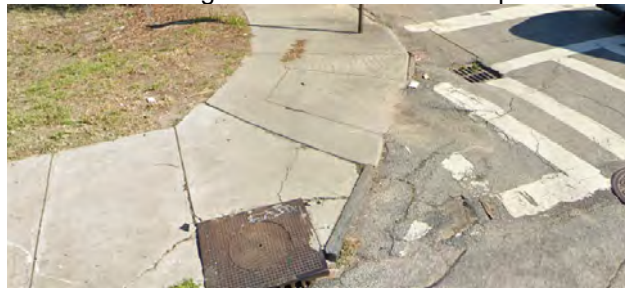
Sections of the sidewalks and ADA ramps are damaged and/or uneven. The sidewalks are also obstructed with utility poles, tree planting boxes, etc. This creates challenges for pedestrians with mobility restrictions. During the audit, a pedestrian in a motorized chair was observed traveling in the parking lane. Additionally, some sidewalks vary in width and some segments are not ADA compliant.

Sidewalk at Line St. approach needs to be repaired.

Perform sidewalk and ramp reconstruction repairs to improve access and mobility. Clean debris from sidewalk.

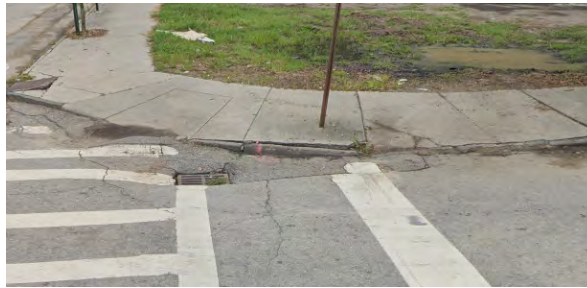
Storm drain inlets are in the roadway, some of which do not accommodate bicycle tires. This requires bicyclists to maneuver around them.

Existing storm drain inlets on the travel lane.

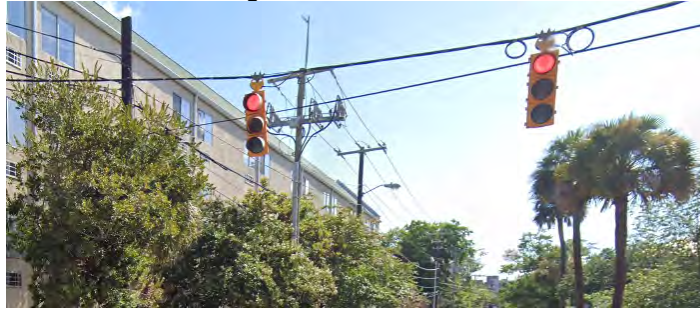
All the signalized intersections lack retroreflective backplates: Spring St., Cannon St., Morris St., Radcliffe St., Vanderhorst St., Calhoun St., and George St.

Existing Vanderhorst St. signal heads without retroreflective backplates.

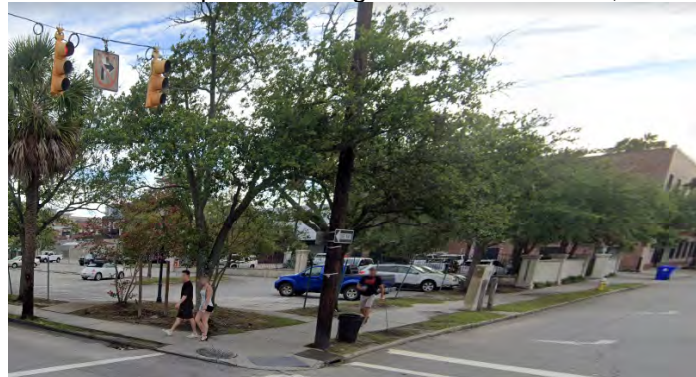
The following intersections do not have pedestrian signal heads: Morris St., and Radcliffe St.

Morris St. intersection without pedestrian signal heads, countdowns and pushbuttons

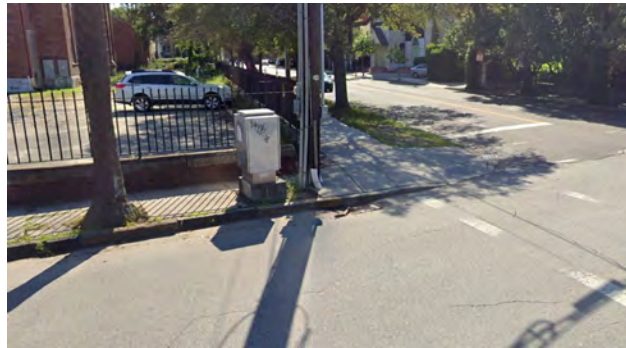
- The ADA ramp at the southwest corner of the intersection does not align with the crosswalk.
- The sidewalk at the southeast corner needs vegetation and sediment removed.
- Traffic signal cabinet and utility pole restrict the sidewalk in the southwest corner of the intersection.

- Consider reconstructing the ramp or relocating the crosswalk at the southwest corner, to make them align, where feasible.
- Clean the sidewalk at the southeast corner.
- Evaluate options for relocating signal cabinet and utility pole to increase effective sidewalk width.

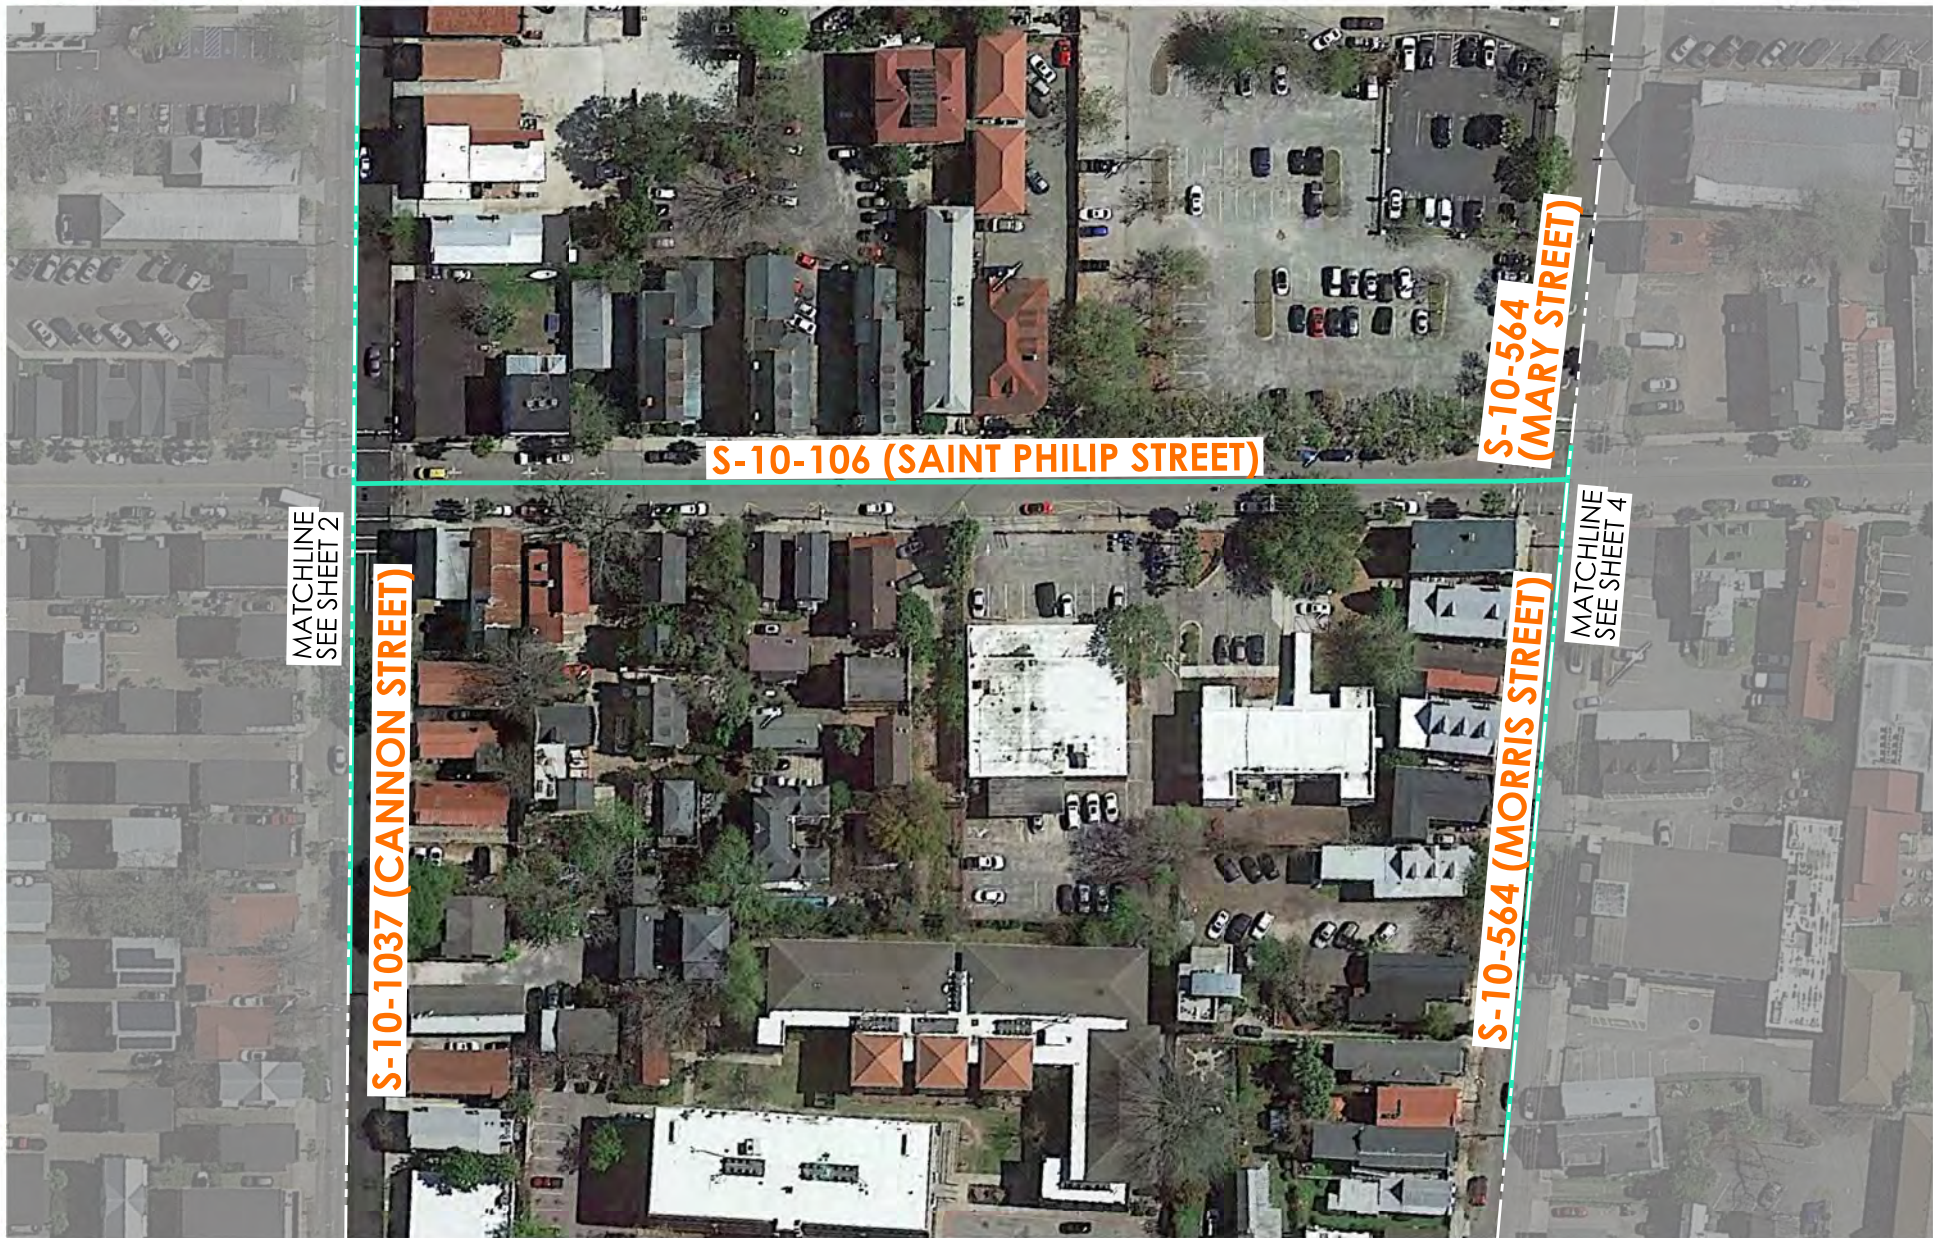
SAINT PHILIP ST
SAFETY IMPROVEMENTS
BLOCK: BOGARD -
CANON ST
SCALE: 1"=100'
SHEET 2 OF 9

PDO: 25
INJURY: 5
FATAL: 0

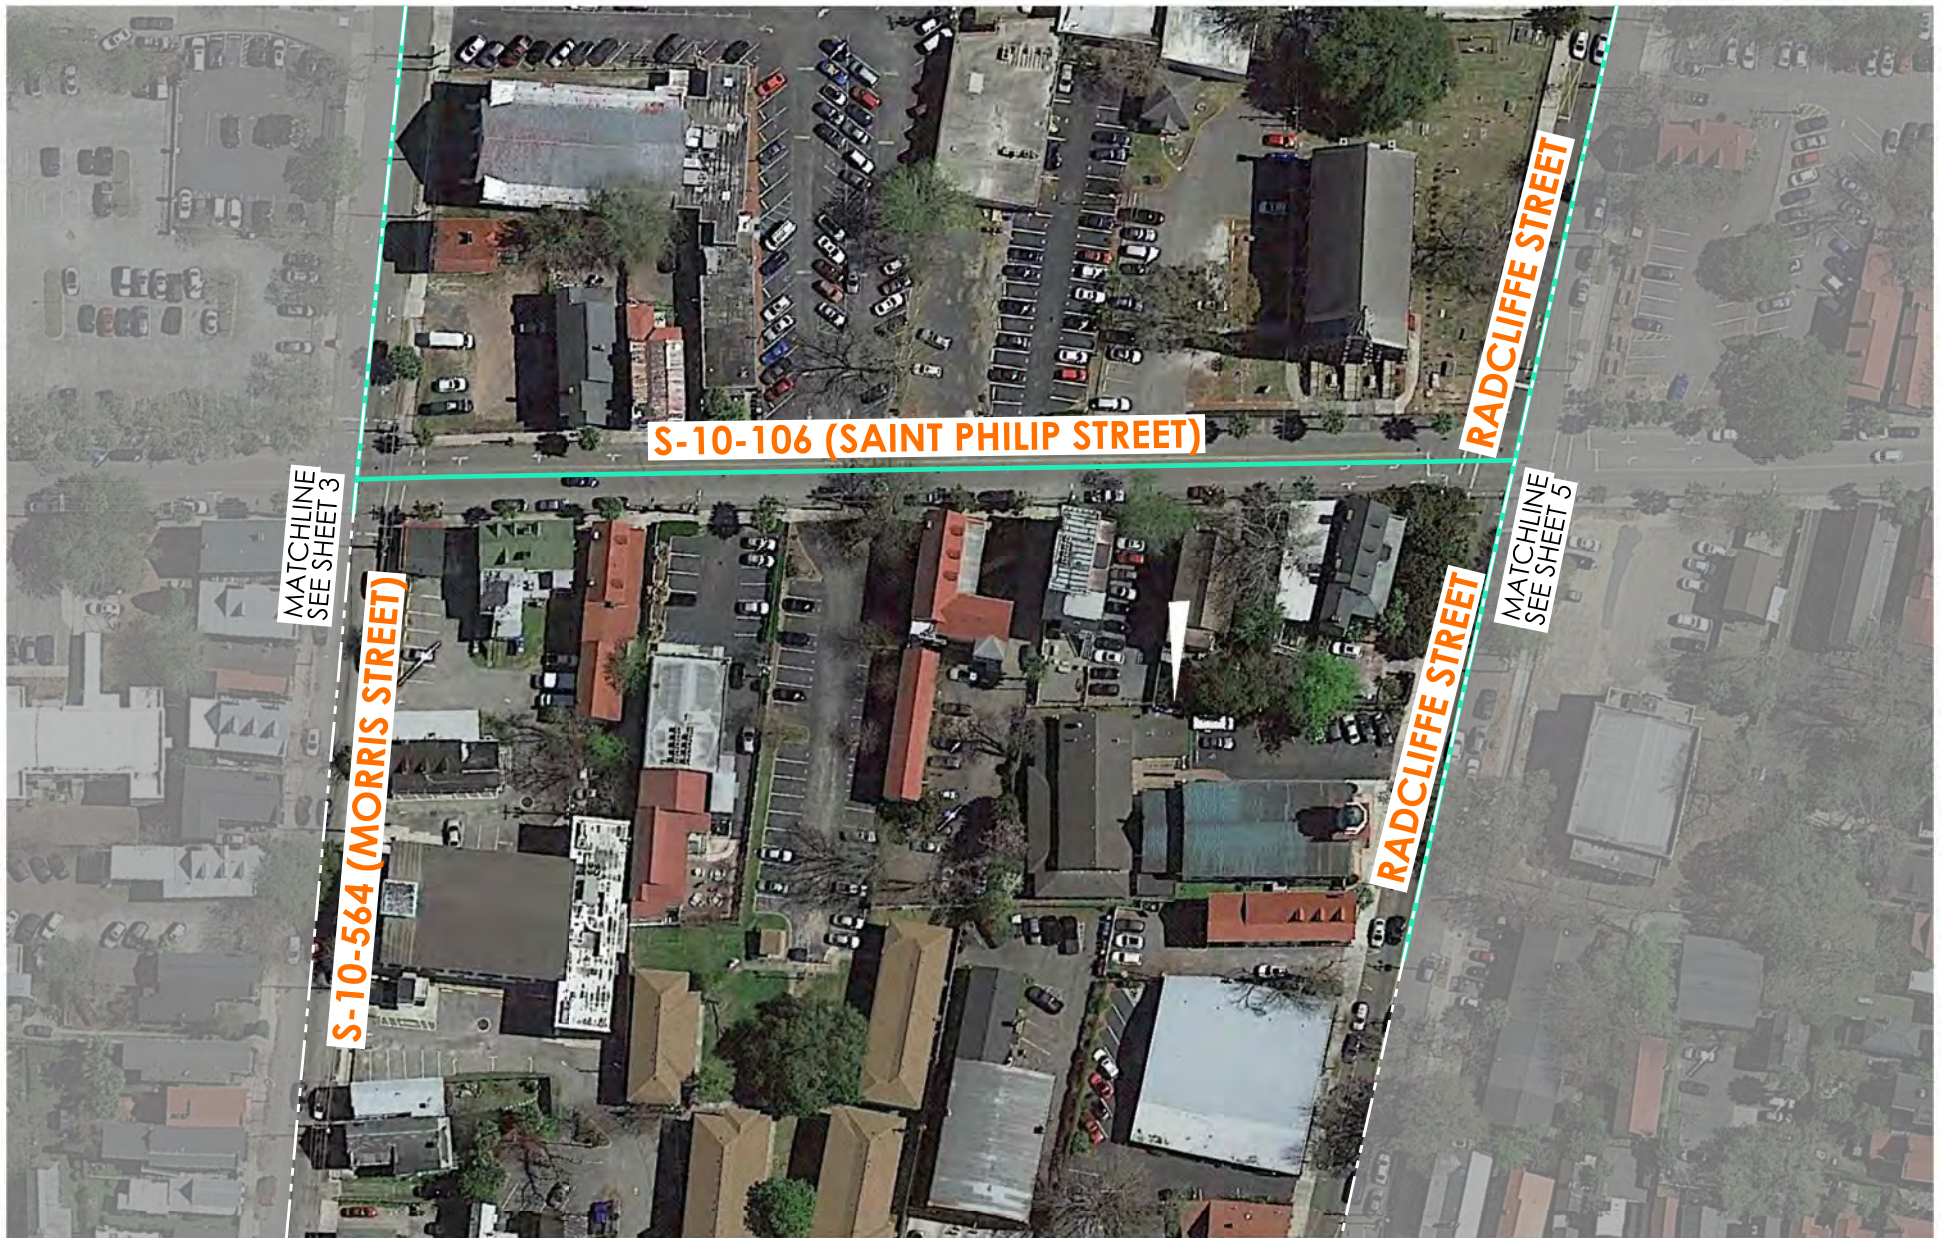
SAINT PHILIP ST
SAFETY IMPROVEMENTS
BLOCK: CANON - MORRIS ST

ANGLE CRASH: 14 SIDESWIPE CRASH: 4
 REAR END CRASH: 2 OTHER CRASH: 9

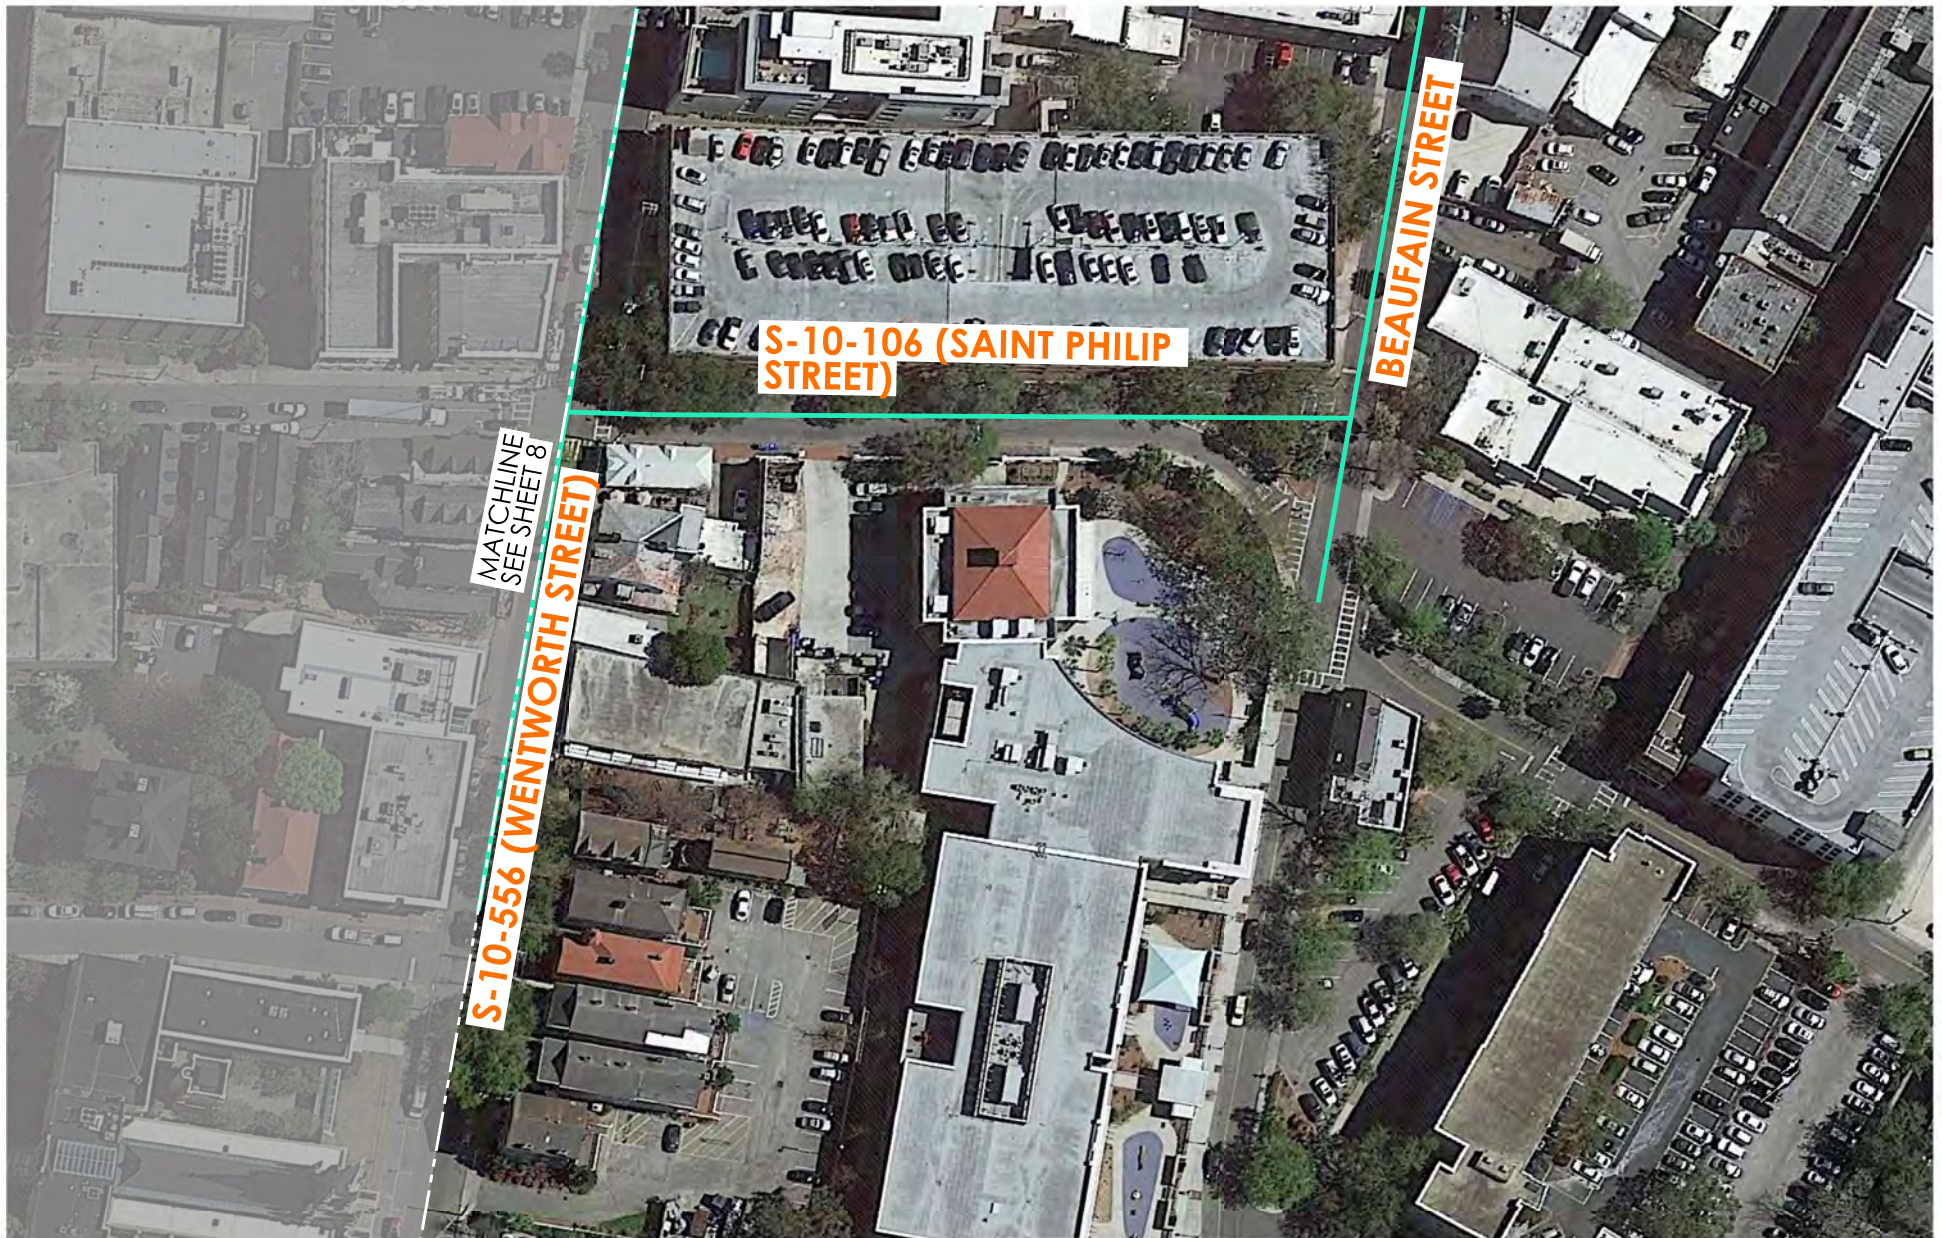
SAINT PHILIP ST
 SAFETY IMPROVEMENTS
 BLOCK: GEORGE ST -
 WENTWORTH ST
 SCALE: 1"=100'
 SHEET 8 OF 9

ANGLE CRASH: 0 SIDESWIPE CRASH: 0
 REAR END CRASH: 0 OTHER CRASH: 0
