SAINT PHILIP STREET

Bicycle and Pedestrian Road Safety Audit Charleston, SC

S-106 Saint Philip Street

Bicycle and Pedestrian Road Safety Audit

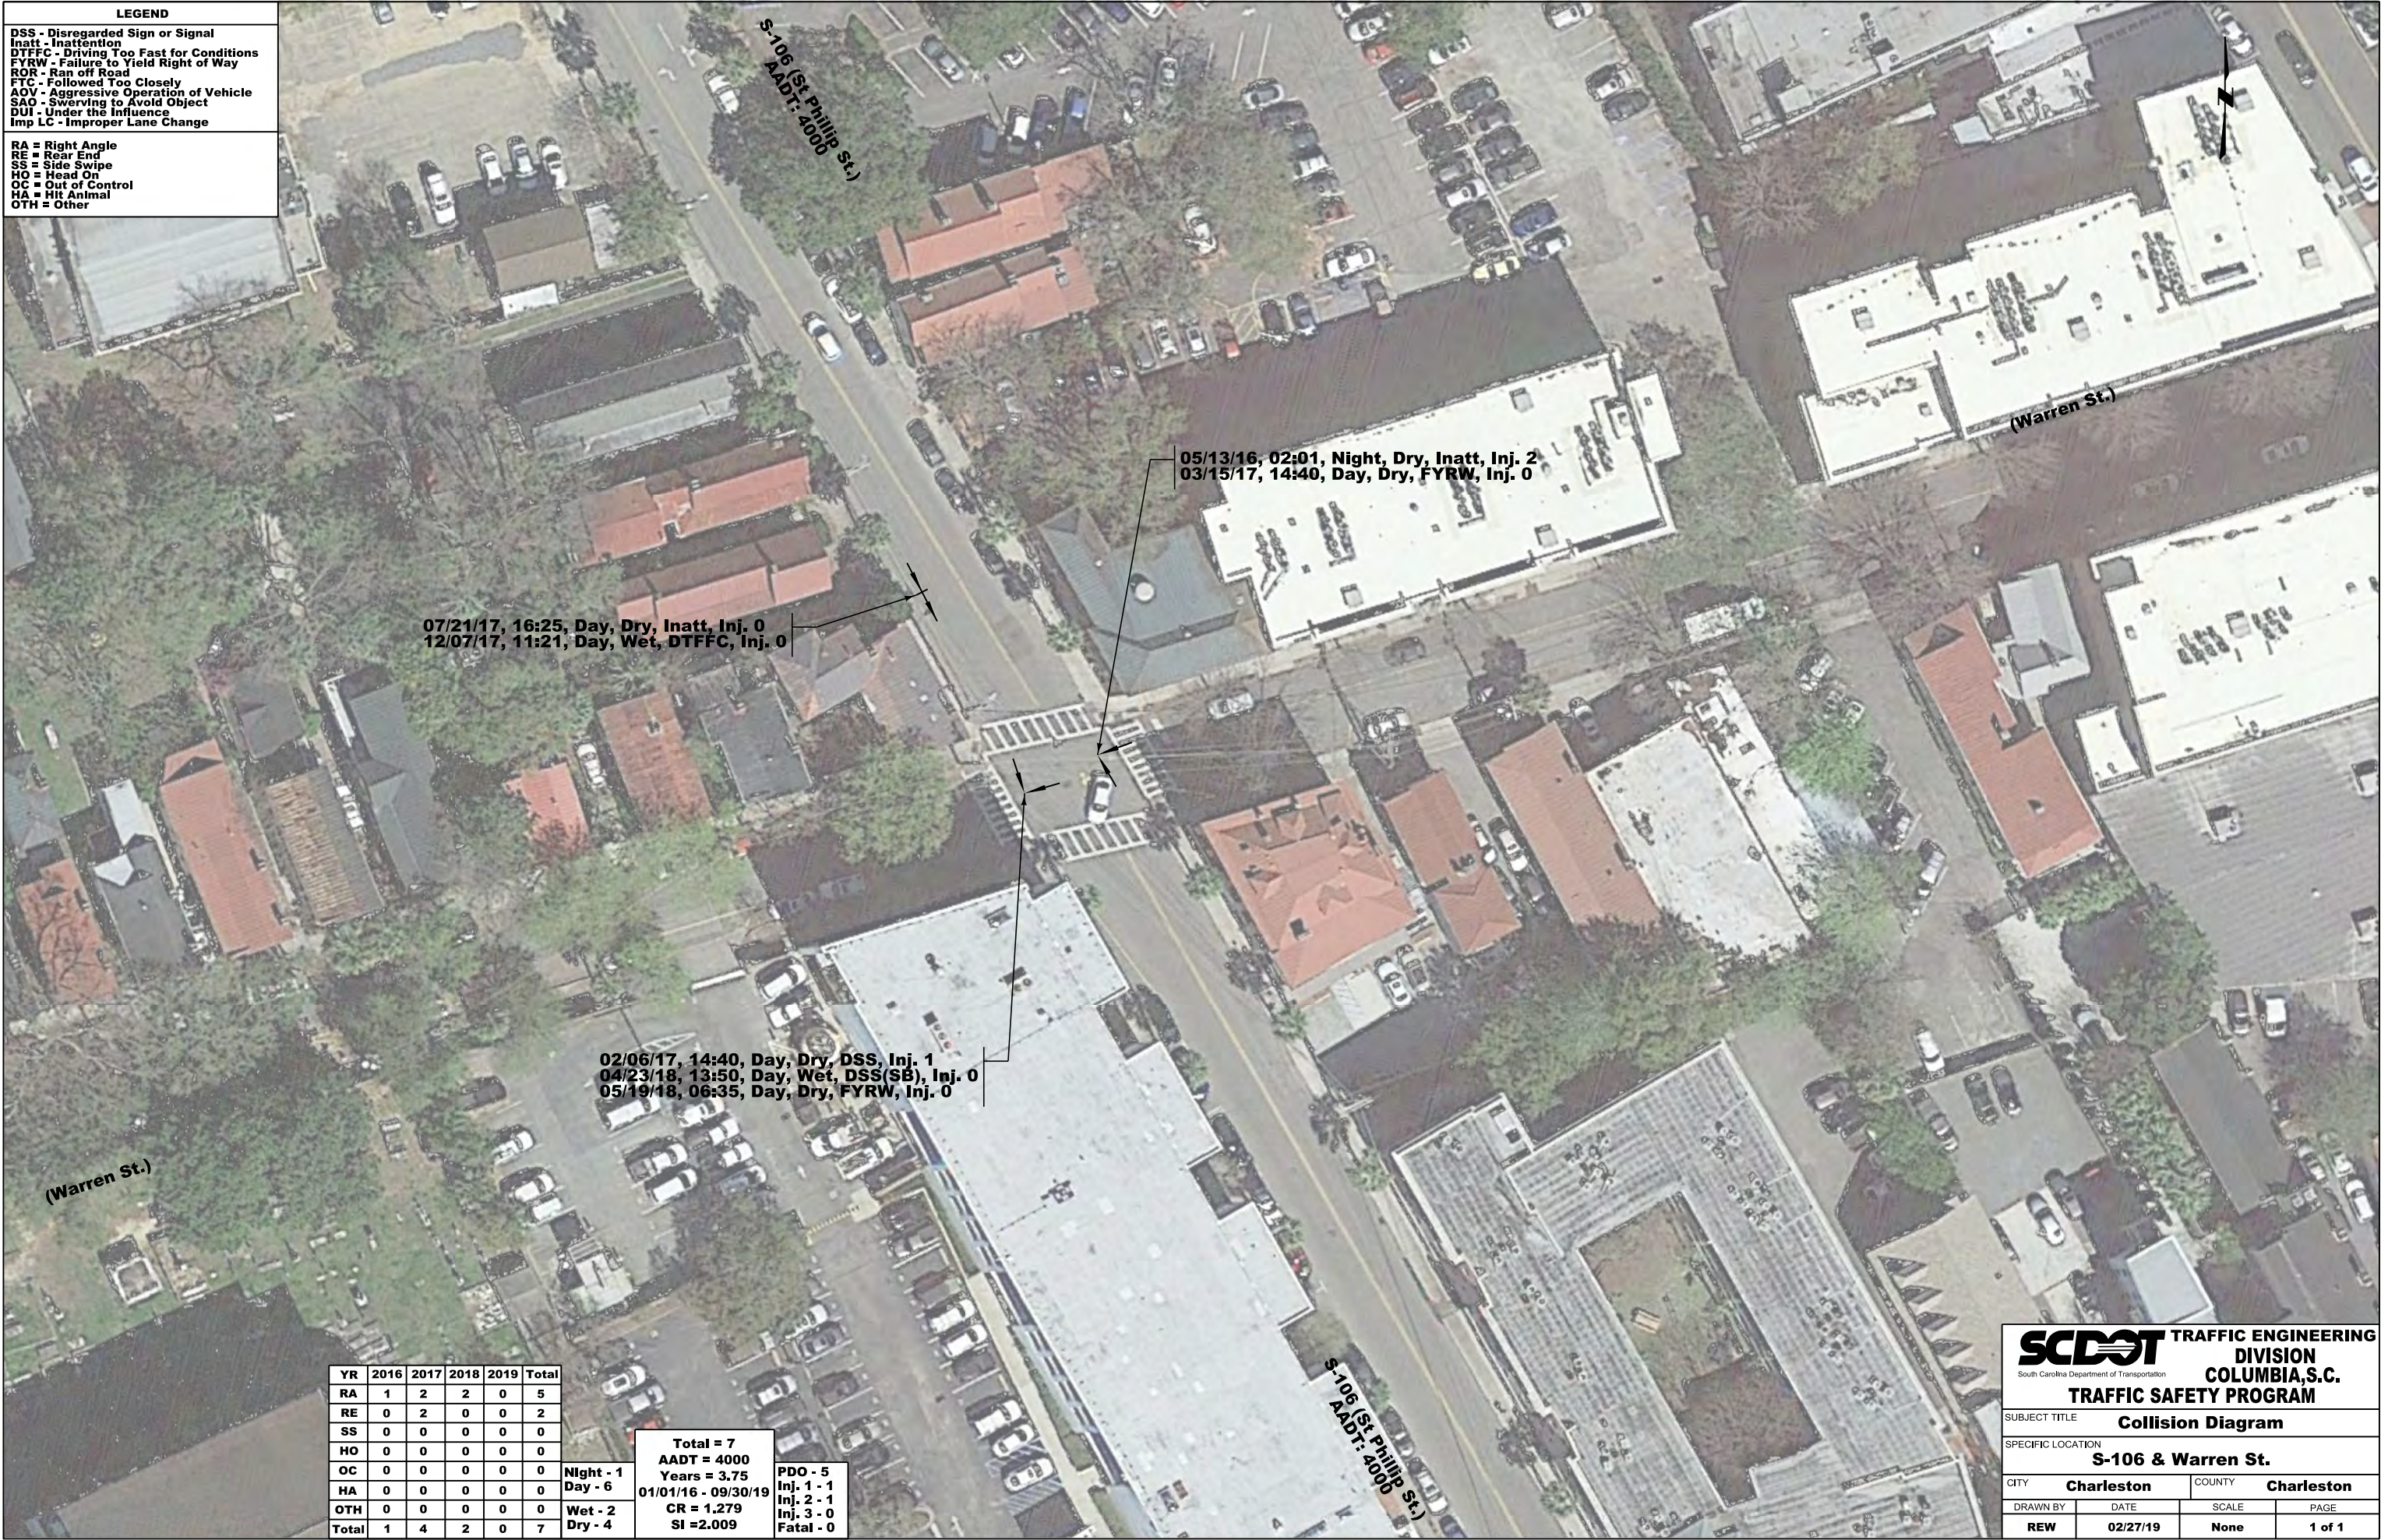
YR	2016	2017	2018	2019	Total
RA	1	2	2	0	5
RE	0	2	0	0	2
SS	0	0	0	0	0
HO	0	0	0	0	0
OC	0	0	0	0	0
HA	0	0	0	0	0
OTH	0	0	0	0	0
Total	1	4	2	0	7

Total = 7
AADT = 4000
Years = 3.75
01/01/16 - 09/30/19
CR = 1,279
SI = 2.009
